# Effective Long-Lasting Partial Depth Joint Repairs for Challenging Conditions

NRRA PREVENTIVE MAINTENANCE TEAM

Report No. NRRA202104

| 16. Abstract (Limit: 250 words)<br><br>As Portland cement concrete (PCC) pavements age, longitudinal and transverse joints can exhibit signs of distress as a result of traffic loading, climatic variations, materials-related issues, and construction defects. Although only small areas are often involved, the joint distress can substantially disrupt traffic flow and increase pavement roughness, sacrificing consumer ride comfort. When immediate action is required, temporary repairs are often made using readily available materials, such as cold mix or other asphalt materials. These temporary materials are often replaced with more permanent materials to reestablish the integrity and functionality of the concrete pavement. The goal of this project is to provide a guide for agencies to establish an effective joint repair program. The final report reviews the background information explaining why this research was performed, summarizes the findings from previous similar research studies, details how the patches were constructed and how they performed, a

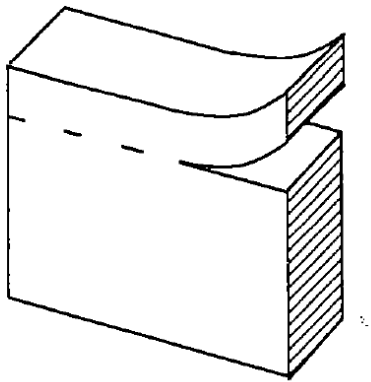
**Figure 3.1 Scored Joint Bond Breaker (Wilson et al., 1999a)**

As a good construction practice, a joint bond breaker should be scored (Figure 3.1) at an appropriate depth prior to installation and, upon curing of the patch material, the top strip of the bond breaker is removed to create a joint sealant reservoir (Wilson et al., 1999a). As Figure 3.2 shows, it is recommended bond breakers extend 1.0 inch (25mm) below and 3 inches (75 mm) beyond the repair boundaries to prevent the patch material from flowing into the joint during placement (Wilson et al., 1999a).

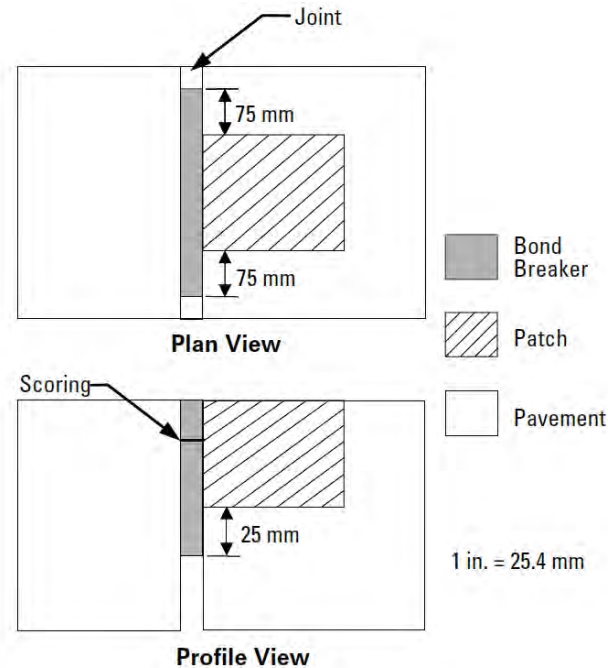
Figure 3.2 Joint Bond Breaker (Wilson et al., 1999a, as reproduced by Smith et al., 2014)

As previously mentioned, joint bond breakers relieve compressive stresses and prevent the repair material from flowing into joints or cracks to impede slab movement. A key recommendation of the SHRP/FHWA partial depth spall repair study (Wilson et al., 1999b) was related to joint restoration. A bond breaker must span the entire vertical face of joints that is exposed during concrete removal. In a Virginia study in which over 10,000 partial depth patches were installed along mostly transverse joints on 400 miles of jointed concrete interstate pavement lanes, Tyson (1977) reported that a large number of the patch failures resulted from lack of joint bond breaker or failure to install a bond breaker to cover the full depth of the patches; the lower portions of the patches were in contact with the adjacent slabs, exposing them to destructive effects of slab movements. Figure 3.2 illustrated a recommended installation procedure for joint bond breakers.

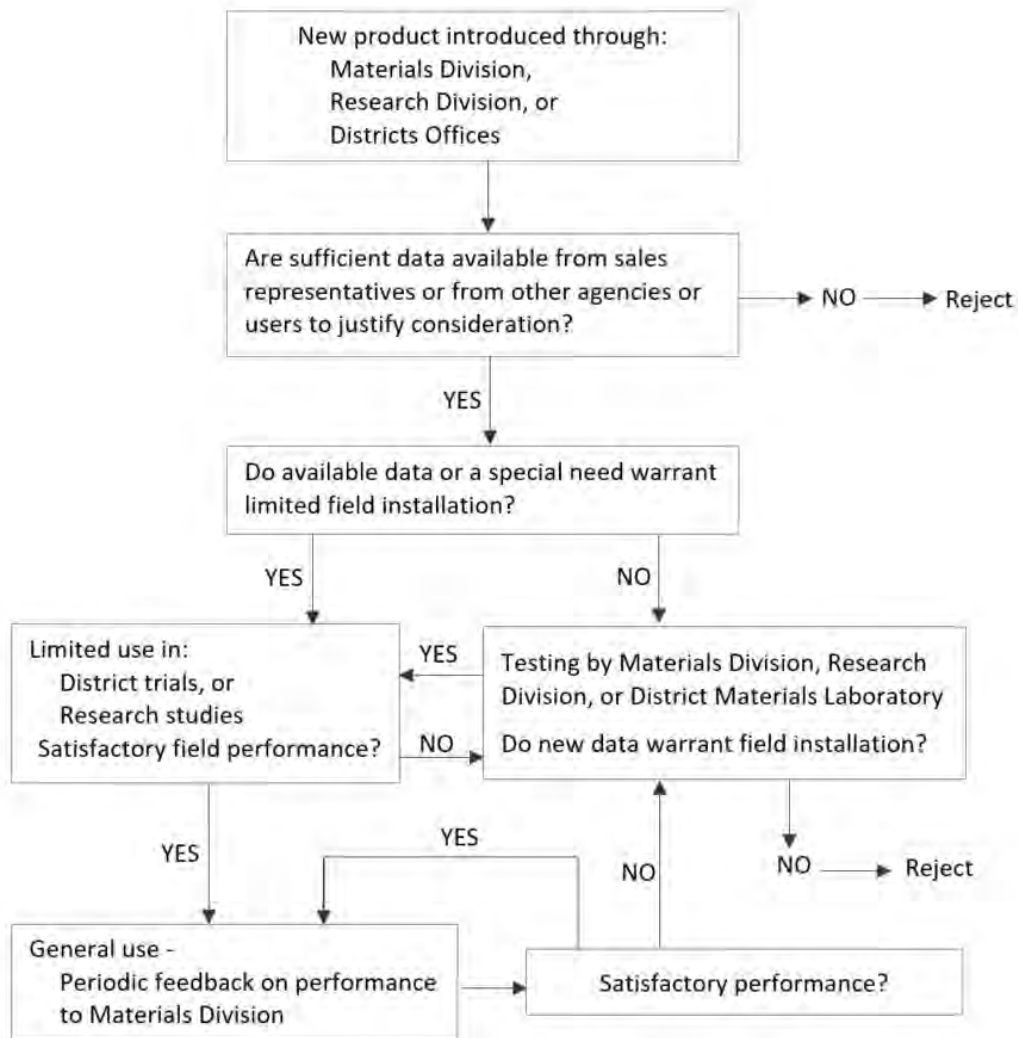
Figure 3.3 Methodology for New Product Evaluation (adapted from Tyson, 1977)

Several products may exhibit satisfactory performance in the field trials and a decision must be made regarding which product should be selected for a particular project. As previously discussed, several factors influence the selection of a repair material. In addition to the factors already discussed, it may also be useful to utilize a production chart that shows relationships between the approximate number of patches that could be installed, using a certain product, and the available lane closure time (Tyson, 1977). Such a chart will be useful, during project planning, to estimate overall lane closure time, provided the number of patches is known.

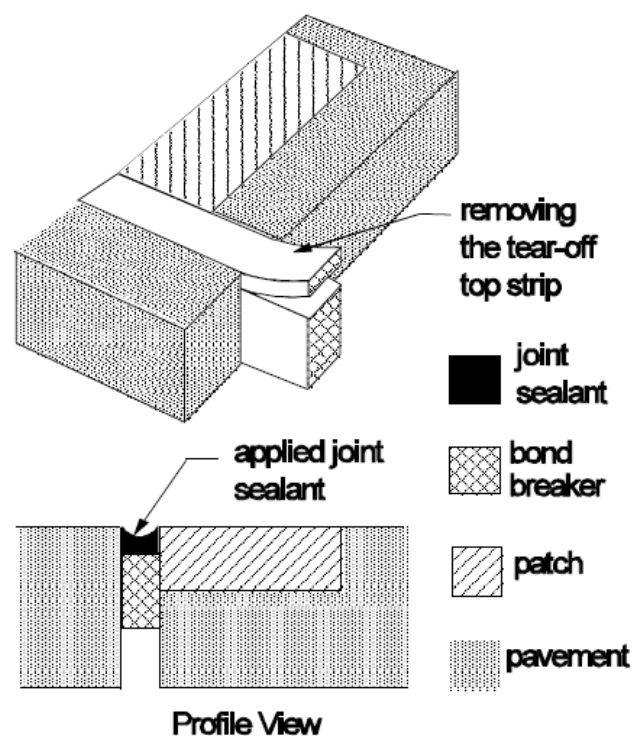
Figure 3.4 Joint Restoration Using Scored Bond Breaker (Wilson et al., 1999a)

The PDR construction process typically ends with joint restoration, which may be accomplished in two ways. If a scored bond breaker was installed prior to placing the repair material, the tear-off strip is removed to create a reservoir for a joint sealant (Figure 3.4). Another approach is to timely saw the full depth of the PDR plus  $\frac{1}{4}$  inch, sandblast and airblast the saw cut, followed by inserting a closed-cell backer rod and applying a joint sealant (Wilson et al., 1999a; Frentress and Harrington, 2012). The SHRP manual entitled *Materials and Procedures for Repair of Joint Seals in Concrete Pavements* (Evans and Romine, 1993) provides more information on joint sealing.

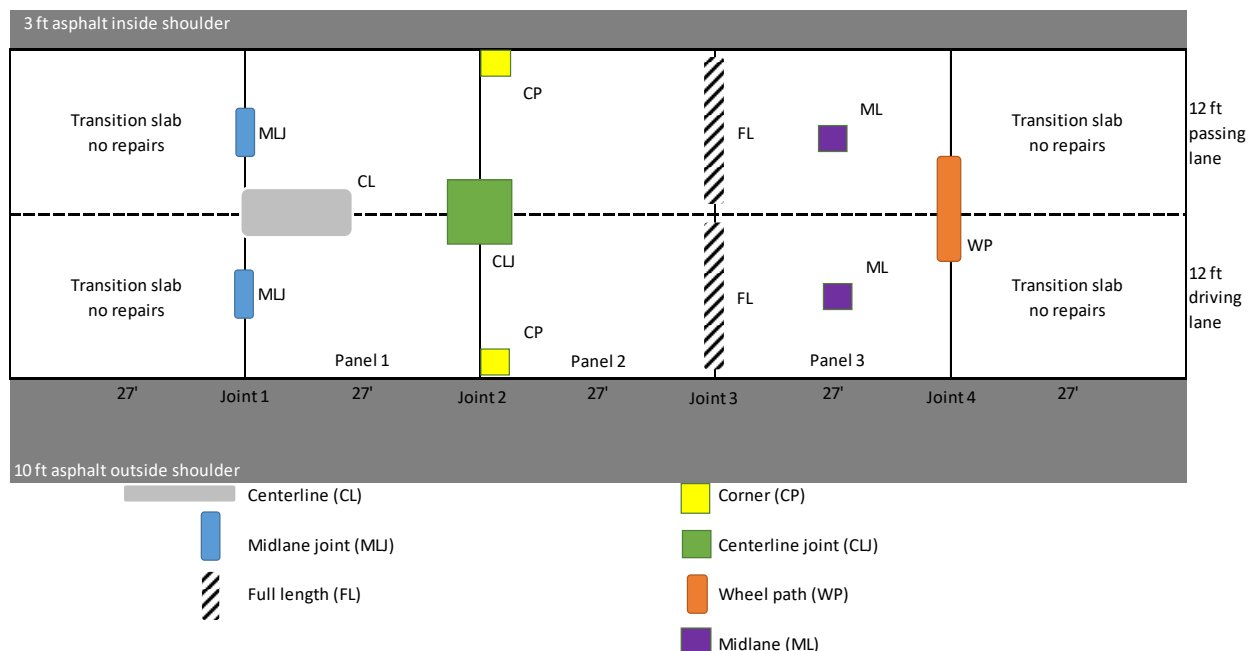
Figure 4.1 Typical Layout of Patching Types for PCC Partial-Depth Repair Study

The figure below provides the typical patching types and locations within a test cell. Note that the order of the patching types varies within each cell, but each cell contains all types. The actual order of the patching types for each test cell are shown in Section 4.3.

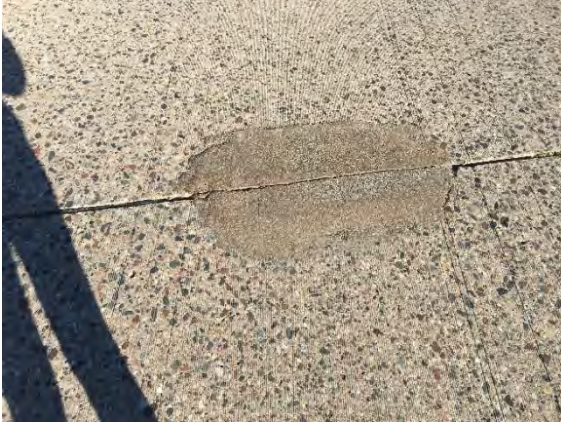
**Figure 4.2 Patch Condition Rating = 4 [No Distress]**

The figures below show examples of patches with each condition rating. During each annual review, the condition of each individual patch was noted. The ratings were then averaged for each different proprietary product. An average patch rating for each product year to year is included in the Product Matrix in Chapter 5.

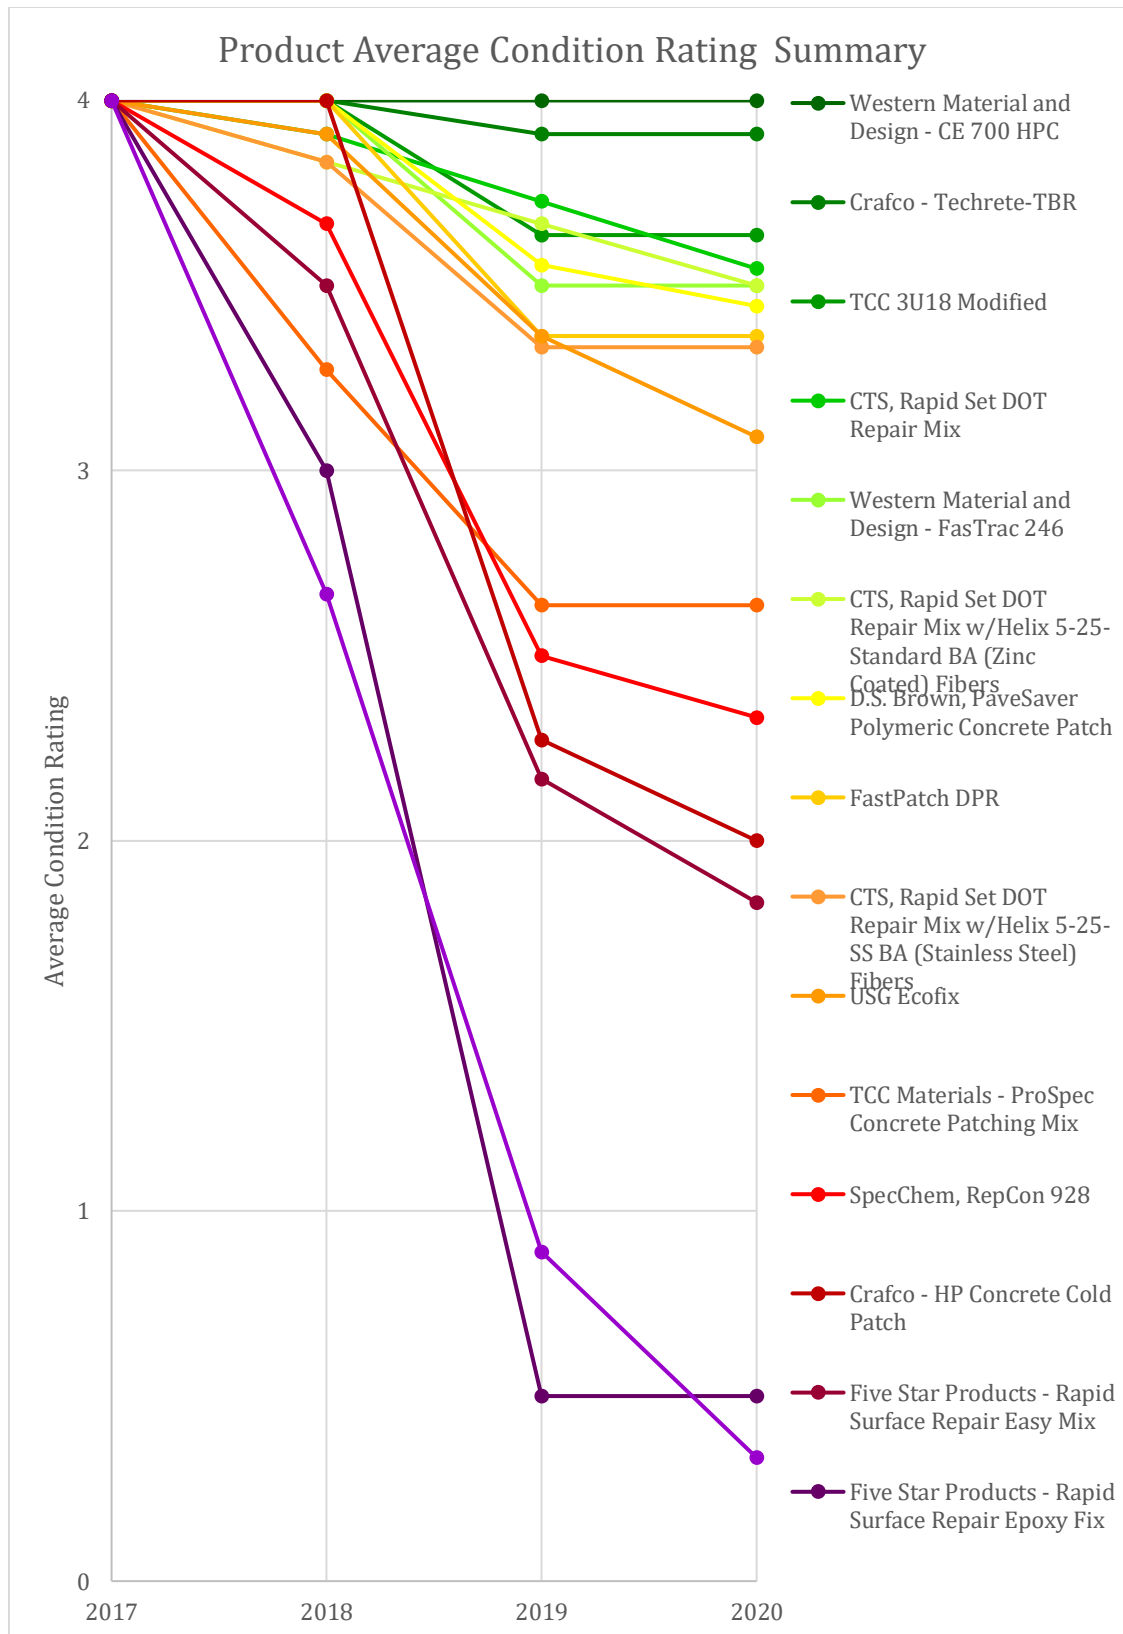
Figure 4.6 Product Average Condition Rating Summary

how long it would take for each product to deteriorate to a condition rating of 1.5. The service life of each product is summarized in Section 4.3 and in the Product Matrix in Chapter 5.

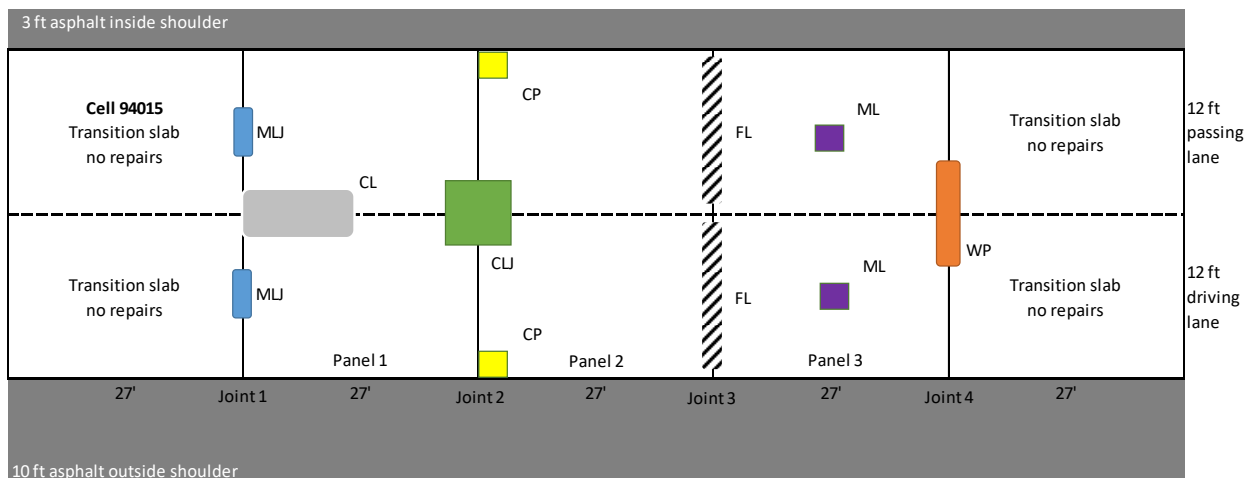
Figure 4.27 Patch Layout for Cell 94015 – Hot Mix Asphalt

The Hot Mix Asphalt was provided by District 3 and installed by MnROAD personnel. All patches were tack coated prior to mix placement. Compaction was achieved utilizing a small drum roller. The time to install the patch material will depend on the size of the distress area, number of batches required, number of crew members, and other such factors; however, installation of a single batch would generally take less than 30 minutes to install. Traffic can be permitted on the patch area immediately after installation is complete.

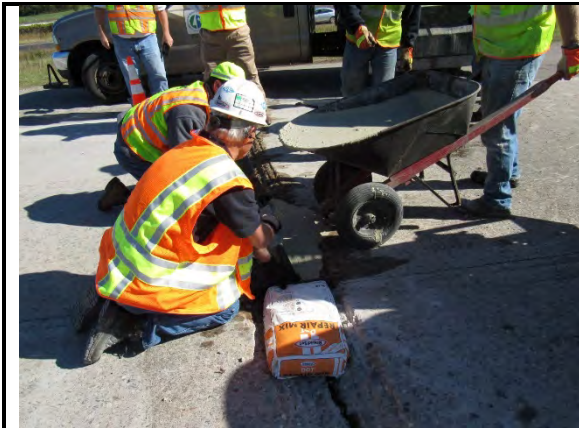
Photograph: 94001 – CTS, Rapid Set DOT Repair Mix  
Subject: Placing mixture

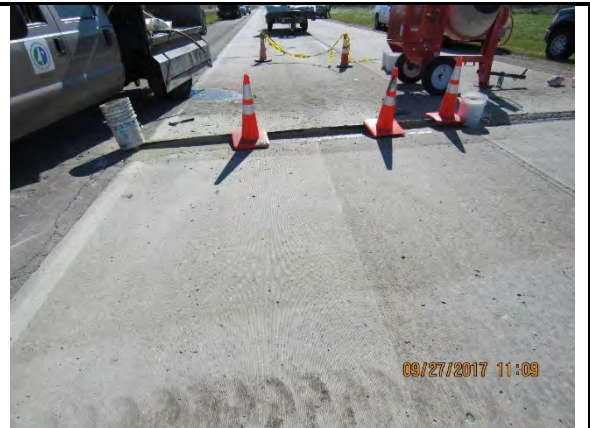
Photograph: 94001 – CTS, Rapid Set DOT Repair Mix  
Subject: Weighing down foam board

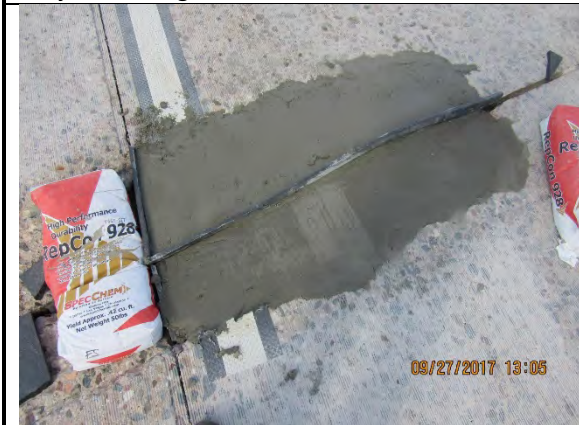
Photograph: 94002 SpecChem, Repcon 928  
Subject: Finished Product

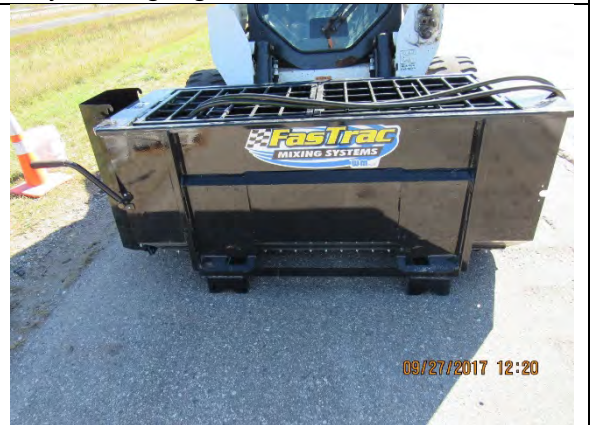
Photograph: 94003 (A) Western Material and Design, FasTrac246  
Subject: Mixer

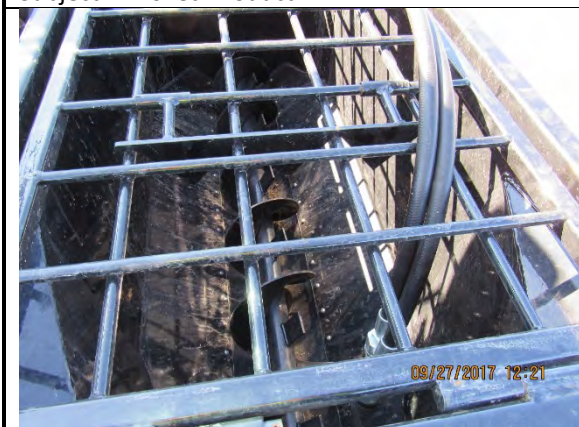
Photograph: 94003 (A) Western Material and Design, FasTrac246  
Subject: Inside of Mixer

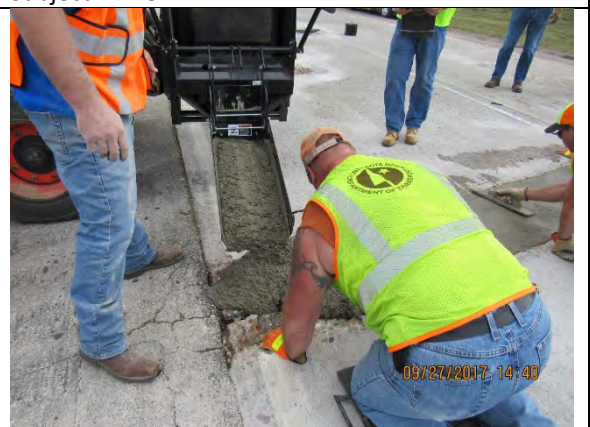
Photograph: 94003 (A) Western Material and Design, FasTrac246  
Subject: Concrete placement

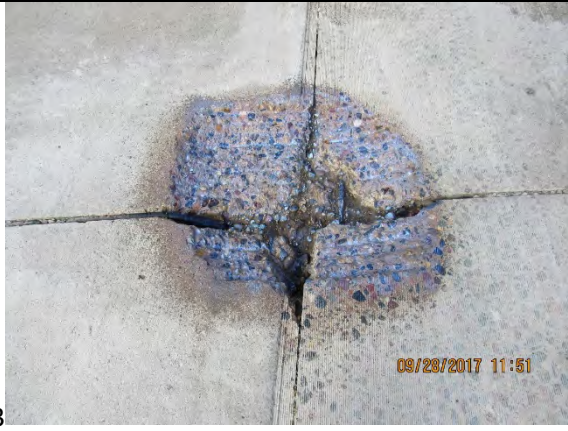
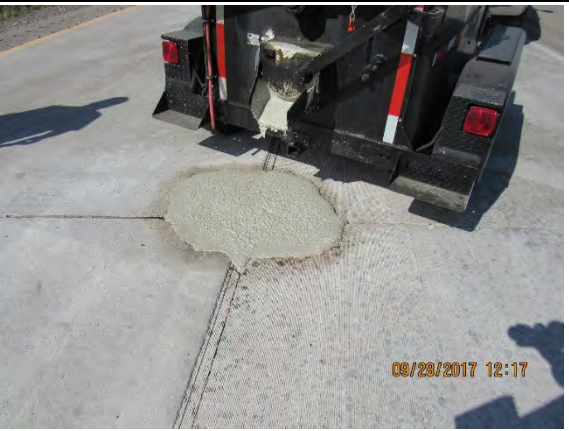
| <p>Photograph: 94010 Crafcro Techcrete-TBR</p> | | <p>Photograph: 94010 Crafcro Techcrete- TBR</p> |

| <p>Subject: Crafcro Patcher (Melter and Mixer)</p> | | <p>Subject: Finishing tool heater</p> |

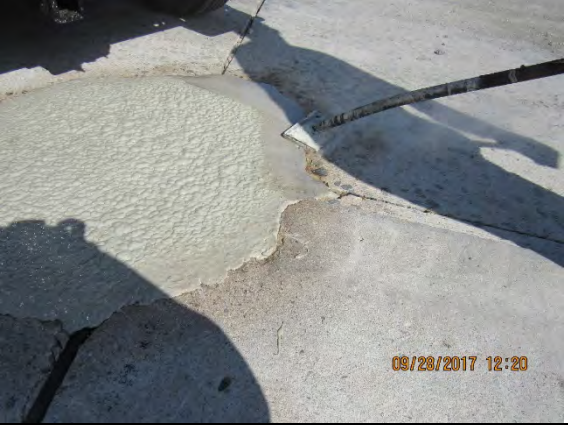
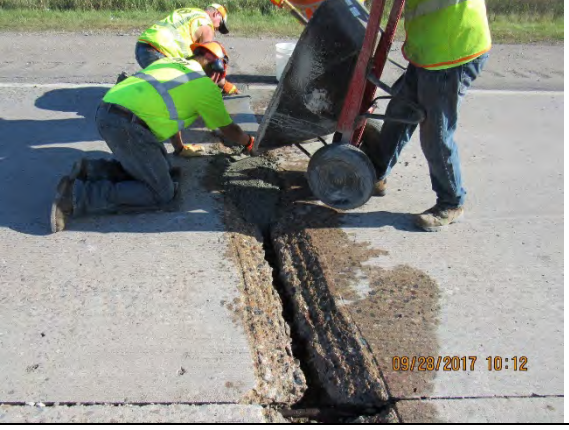
| <p>Photograph: 94010 Crafcotechrete-TBR</p> <p>Subject: Primed Patch</p> | <p>Photograph: 94010 Crafcotechrete-TBR</p> <p>Subject: Placed Patch Material</p> |

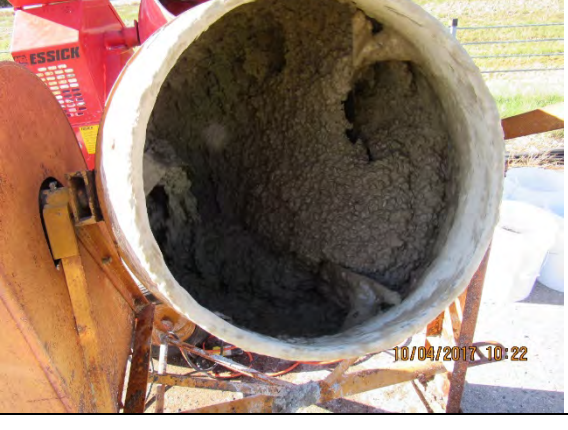
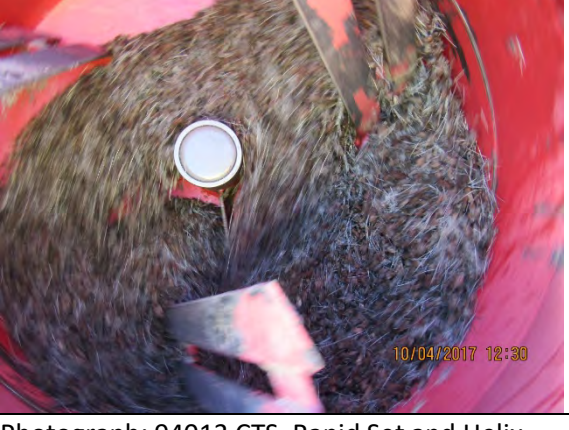
| <p>Photograph: 94010 Crafcotechrete- TBR</p> <p>Subject: Finishing patch material</p> | <p>Photograph: 94011 3U18M</p> <p>Subject: Placing and finishing material</p> |

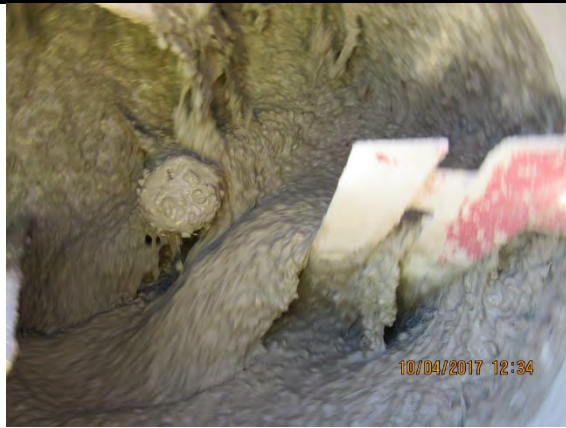
| <p>Photograph: 94012 USG Ecofix</p> <p>Subject: Material mixing in revolving drum</p> | <p>Photograph: 94013 CTS, Rapid Set and Helix Fiber</p> <p>Subject: Fibers and aggregate mixing</p> |

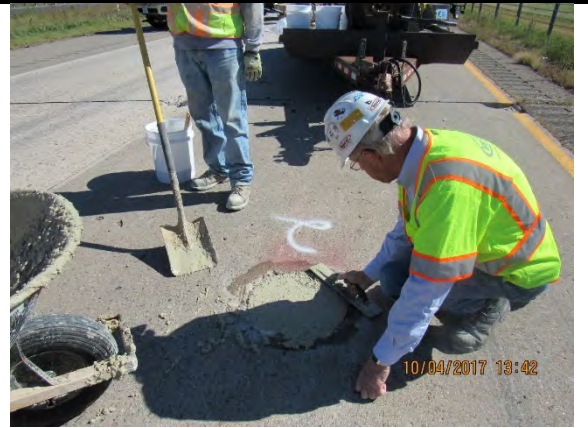
Photograph: 94013 CTS, Rapid set and Helix Fiber  
Subject: Finishing of products with steel fibers

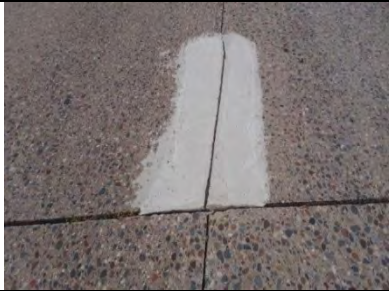
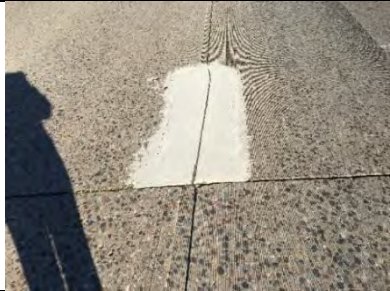
| Cell/Product/Location: 94001 – CTS, Rapid Set DOT Repair Mix – Driving MLJ | | |

| 2018 Condition (Rating): No distress (4) | 2019 Condition (Rating): Shrinkage cracks (4) | 2020 Condition (Rating): Shrinkage cracks (4) |

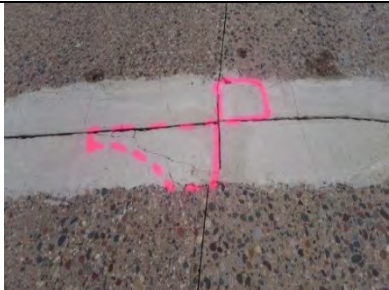
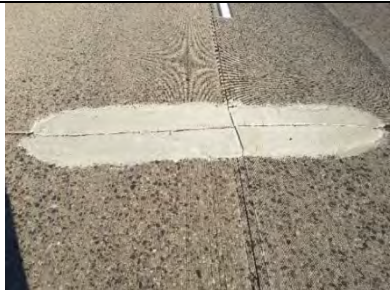
| Cell/Product/Location: 94001 – CTS, Rapid Set DOT Repair Mix – CL | | |

| 2018 Condition (Rating): No distress (4) | 2019 Condition (Rating): Shrinkage cracks (4) | 2020 Condition (Rating): Shrinkage cracks (4) |

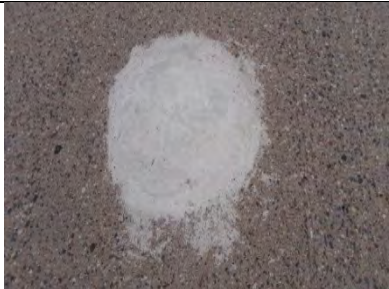
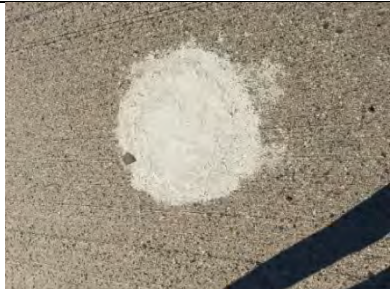
| Cell/Product/Location: 94001 – CTS, Rapid Set DOT Repair Mix – WP | | |

| 2018 Condition (Rating): No distress (4) | 2019 Condition (Rating): Shrinkage and linear cracks (3) | 2020 Condition (Rating): Shrinkage and linear cracks, <50% patch gone (2) |

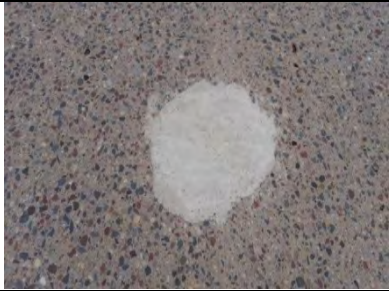
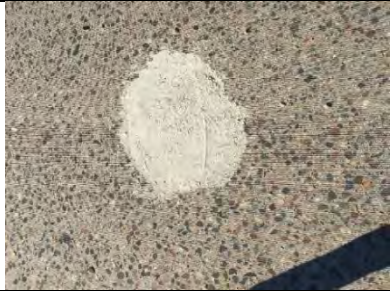
| Cell/Product/Location: 94001 – CTS, Rapid Set DOT Repair Mix – Passing ML | | |

| 2018 Condition (Rating): No distress (4) | 2019 Condition (Rating): Shrinkage cracks (4) | 2020 Condition (Rating): Shrinkage cracks (4) |

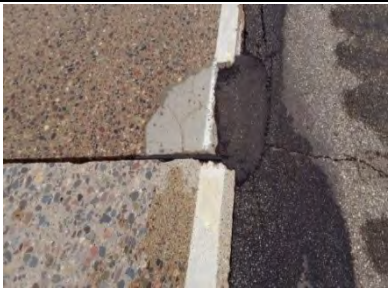
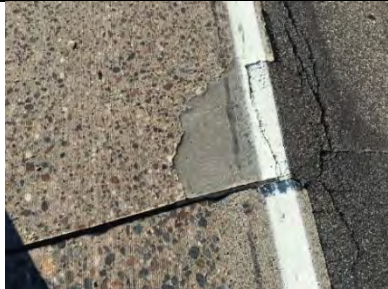
| Cell/Product/Location: 94002(A) – SpecChem, RepCon 928 – CLJ | | |

| 2018 Condition (Rating): Linear cracks (3) | 2019 Condition (Rating): Linear cracks (3) | 2020 Condition (Rating): Linear cracks, <50% patch gone (2) |

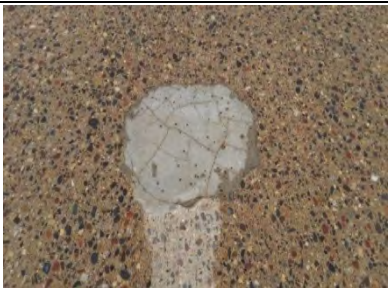
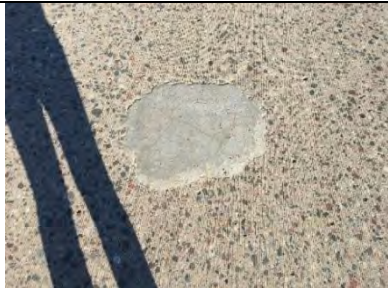
| Cell/Product/Location: 94002(A) – SpecChem, RepCon 928 – Driving CP | | |

| 2018 Condition (Rating): No distress (4) | 2019 Condition (Rating): Linear cracks (3) | 2020 Condition (Rating): Linear cracks (3) |

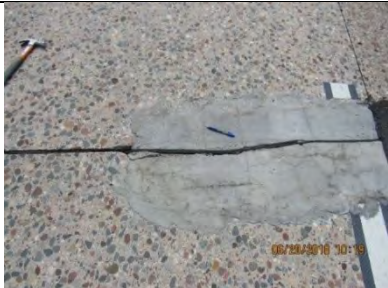
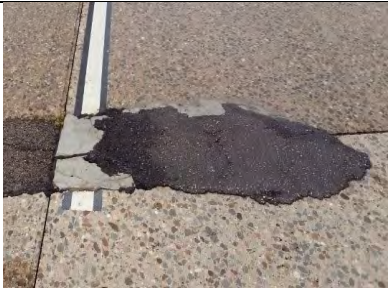
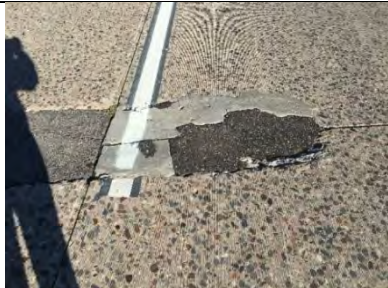
| Cell/Product/Location: 94002(A) – SpecChem, RepCon 928 – Driving ML | | |

| 2018 Condition (Rating): No distress (4) | 2019 Condition (Rating): Linear cracks (3) | 2020 Condition (Rating): Linear cracks (3) |

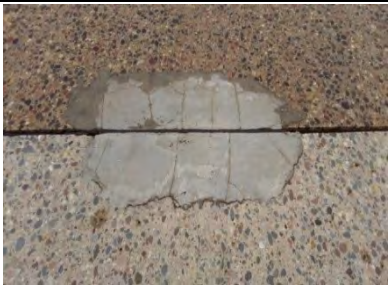
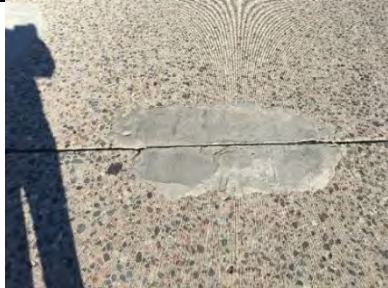
| Cell/Product/Location: 94002(A) – SpecChem, RepCon 928 – Driving WP | | |

| 2018 Condition (Rating): Linear cracks (3) | 2019 Condition (Rating): Linear cracks, >50% patch gone (1) | 2020 Condition (Rating): Linear cracks, >50% patch gone (1) |

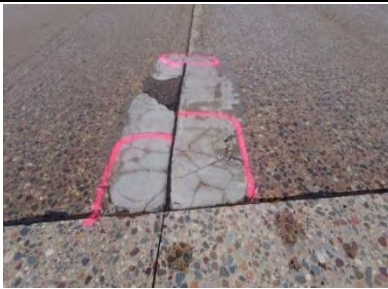
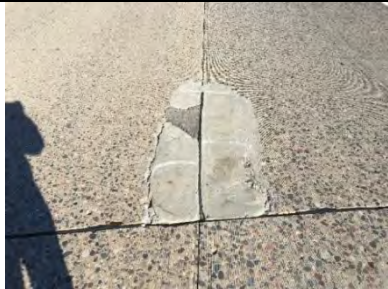
| Cell/Product/Location: 94002(A) – SpecChem, RepCon 928 – Driving MLJ | | |

| 2018 Condition (Rating): No distress (4) | 2019 Condition (Rating): Linear cracks (3) | 2020 Condition (Rating): Linear cracks (3) |

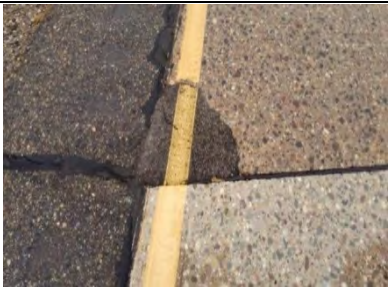
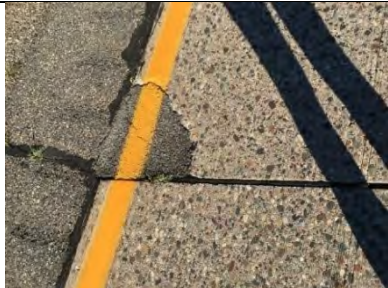
| Cell/Product/Location: 94002(A) – SpecChem, RepCon 928 – CL | | |

| 2018 Condition (Rating): No distress (4) | 2019 Condition (Rating): Linear cracks, <50% patch gone (2) | 2020 Condition (Rating): Linear cracks, <50% patch gone (2) |

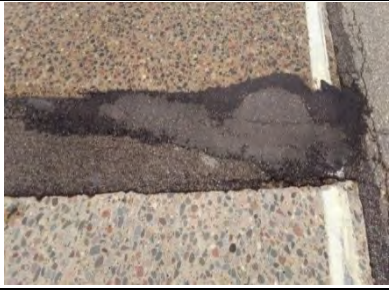
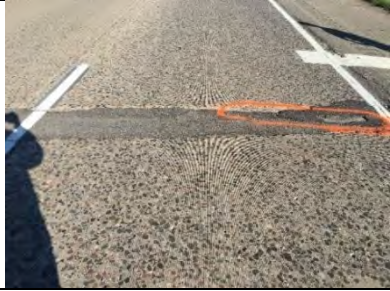
| Cell/Product/Location: 94002(B) – HMA – Passing FL | | |

| 2018 Condition (Rating): N/A | 2019 Condition (Rating): N/A | 2020 Condition (Rating): N/A |

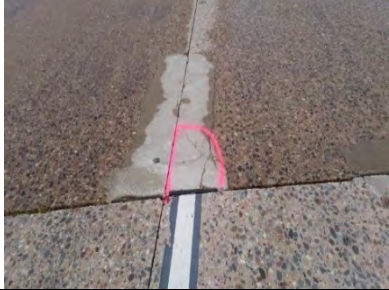
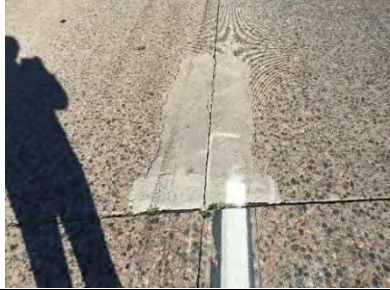
| Cell/Product/Location: 94002(B) – HMA – Driving FL | | |

| 2018 Condition (Rating): N/A | 2019 Condition (Rating): N/A | 2020 Condition (Rating): N/A |

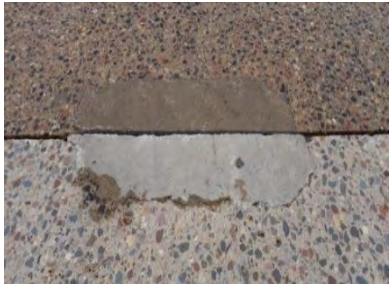
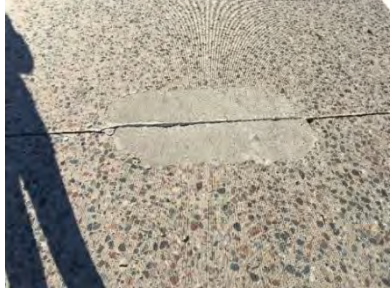
| Cell/Product/Location: 94003(A) – Western Material and Design, FasTrac 246 – CL | | |

| 2018 Condition (Rating): No distress (4) | 2019 Condition (Rating): Linear cracks (3) | 2020 Condition (Rating): Linear cracks (3) |

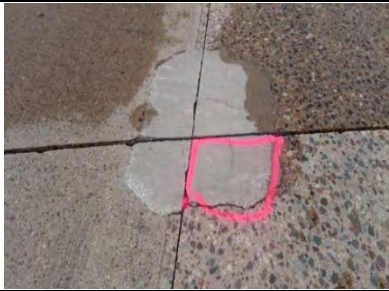
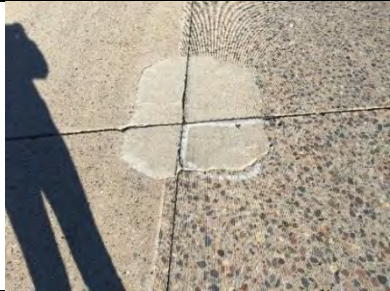
| Cell/Product/Location: 94003(A) – Western Material and Design, FasTrac 246 – Driving MLJ | | |

| 2018 Condition (Rating): No distress (4) | 2019 Condition (Rating): Shrinkage cracks (4) | 2020 Condition (Rating): Shrinkage cracks (4) |

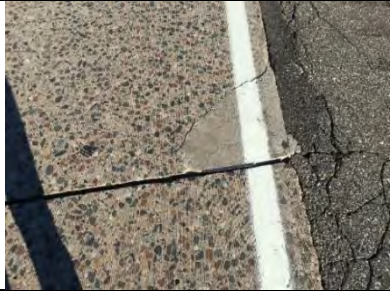
| Cell/Product/Location: 94003(A) – Western Material and Design, FasTrac 246 – CLJ | | |

| 2018 Condition (Rating): No distress (4) | 2019 Condition (Rating): Shrinkage cracks, debonded (3) | 2020 Condition (Rating): Shrinkage and linear cracks, debonded (3) |

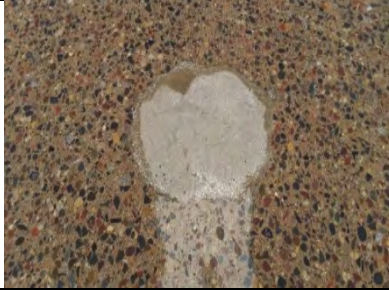
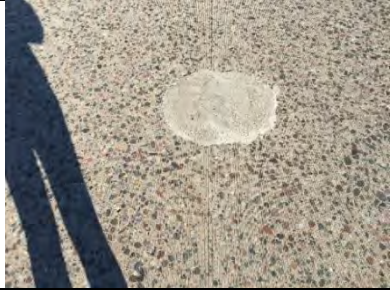
| Cell/Product/Location: 94003(A) – Western Material and Design, FasTrac 246 – Driving CP | | |

| 2018 Condition (Rating): No distress (4) | 2019 Condition (Rating): No distress (4) | 2020 Condition (Rating): No distress (4) |

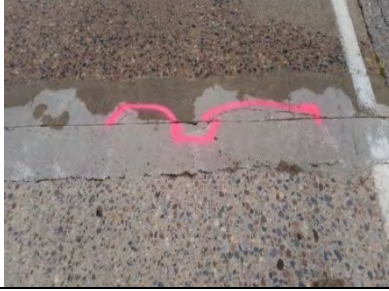
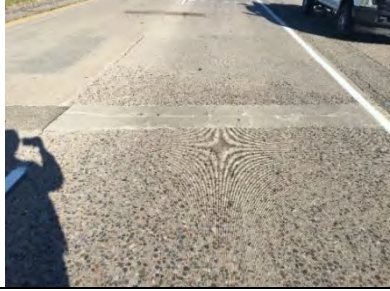
| Cell/Product/Location: 94003(A) – Western Material and Design, FasTrac 246 – Driving ML | | |

| 2018 Condition (Rating): No distress (4) | 2019 Condition (Rating): Shrinkage cracks (4) | 2020 Condition (Rating): Shrinkage cracks (4) |

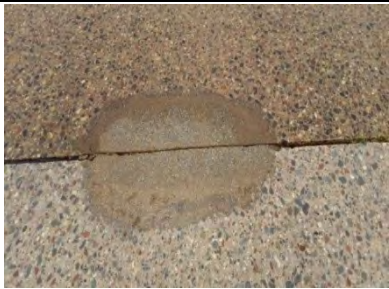
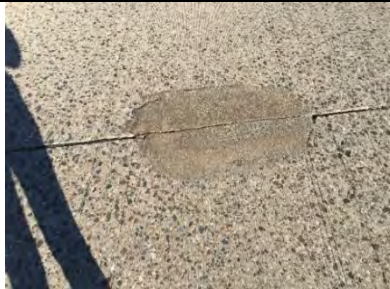
| Cell/Product/Location: 94003(A) – Western Material and Design, FasTrac 246 – Driving FL | | |

| 2018 Condition (Rating): No distress (4) | 2019 Condition (Rating): Shrinkage and linear cracks (3) | 2020 Condition (Rating): Shrinkage and linear cracks (3) |

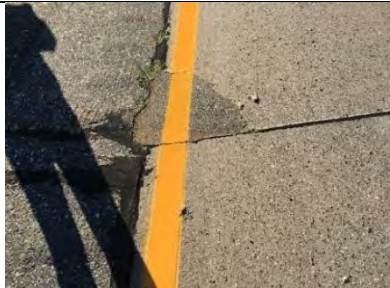
| Cell/Product/Location: 94003(B) - Western Material and Design, CE 700 HPC – Passing MLJ | | |

| 2018 Condition (Rating): No distress (4) | 2019 Condition (Rating): No distress (4) | 2020 Condition (Rating): No distress (4) |

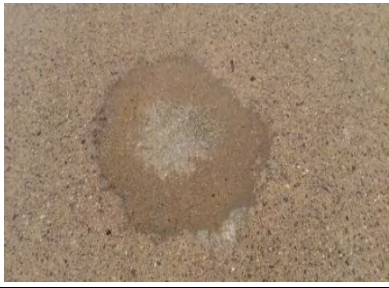
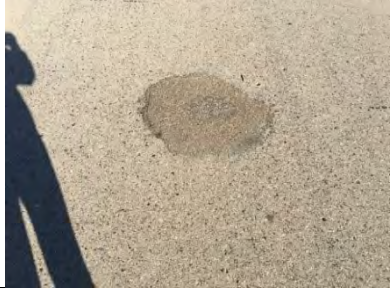
| Cell/Product/Location: 94003(B) - Western Material and Design, CE 700 HPC – Passing CP | | |

| 2018 Condition (Rating): No distress (4) | 2019 Condition (Rating): No distress (4) | 2020 Condition (Rating): No distress (4) |

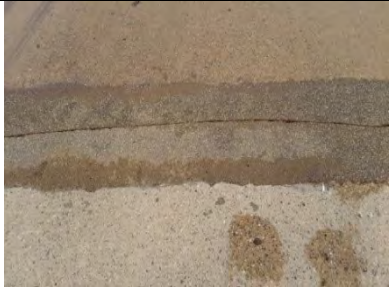
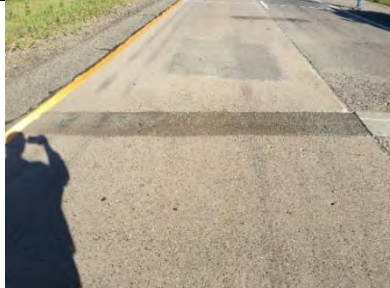
| Cell/Product/Location: 94003(B) - Western Material and Design, CE 700 HPC – Passing ML | | |

| 2018 Condition (Rating): No distress (4) | 2019 Condition (Rating): No distress (4) | 2020 Condition (Rating): No distress (4) |

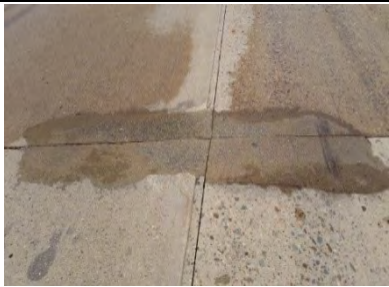
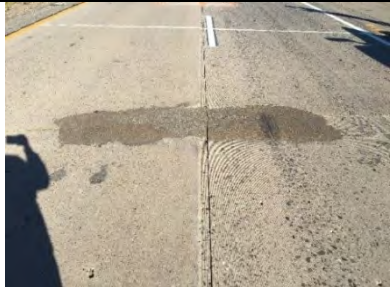
| Cell/Product/Location: 94003(B) - Western Material and Design, CE 700 HPC – Passing FL | | |

| 2018 Condition (Rating): No distress (4) | 2019 Condition (Rating): No distress (4) | 2020 Condition (Rating): No distress (4) |

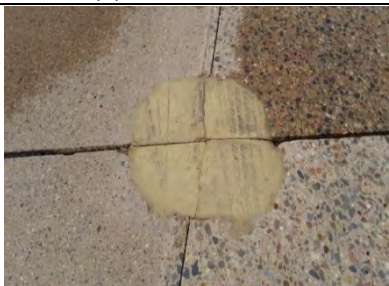
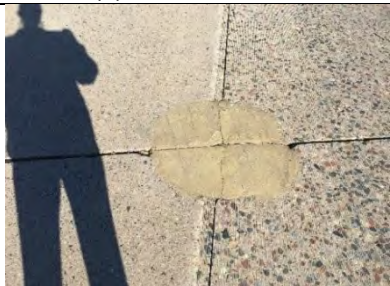
| Cell/Product/Location: 94003(B) - Western Material and Design, CE 700 HPC – WP | | |

| 2018 Condition (Rating): No distress (4) | 2019 Condition (Rating): No distress (4) | 2020 Condition (Rating): No distress (4) |

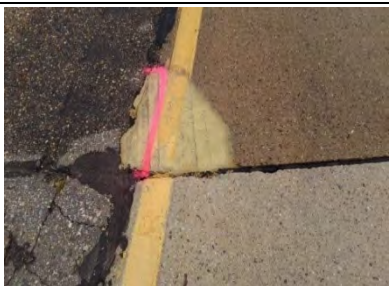
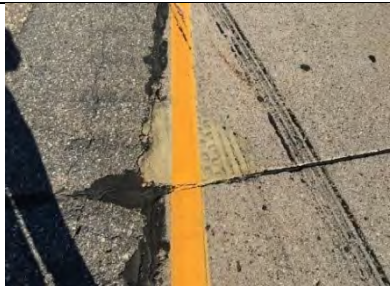
| Cell/Product/Location: 94004(A) – DS Brown, PaveSaver Polymeric Concrete Patch – CLJ | | |

| 2018 Condition (Rating): No distress (4) | 2019 Condition (Rating): Linear cracks (3) | 2020 Condition (Rating): Linear cracks (3) |

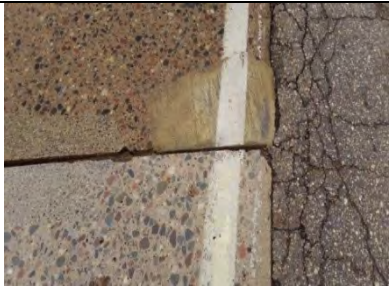
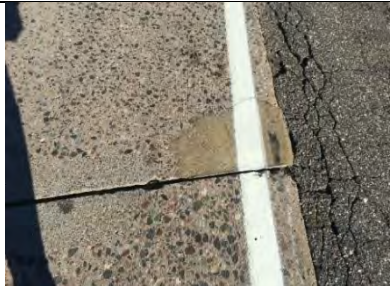
| Cell/Product/Location: 94004(A) – DS Brown, PaveSaver Polymeric Concrete Patch – Passing CP | | |

| 2018 Condition (Rating): No distress (4) | 2019 Condition (Rating): Debonded (3) | 2020 Condition (Rating): Debonded (3) |

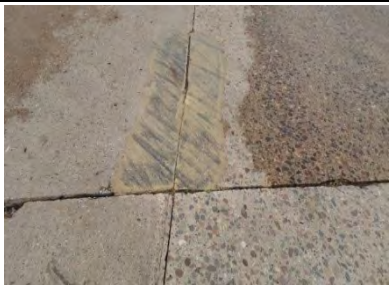
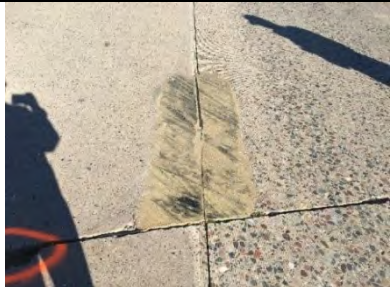
| Cell/Product/Location: 94004(A) – DS Brown, PaveSaver Polymeric Concrete Patch – Driving CP | | |

| 2018 Condition (Rating): No distress (4) | 2019 Condition (Rating): No distress (4) | 2020 Condition (Rating): No distress (4) |

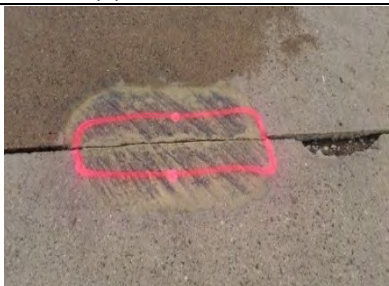
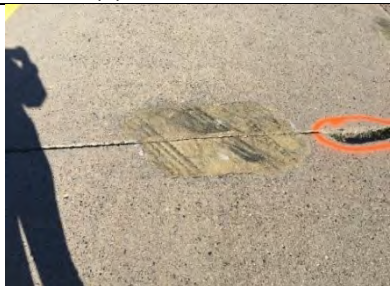
| Cell/Product/Location: 94004(A) – DS Brown, PaveSaver Polymeric Concrete Patch – CL | | |

| 2018 Condition (Rating): No distress (4) | 2019 Condition (Rating): No distress (4) | 2020 Condition (Rating): No distress (4) |

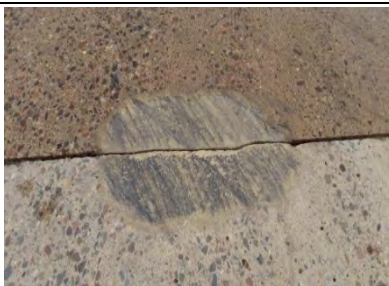
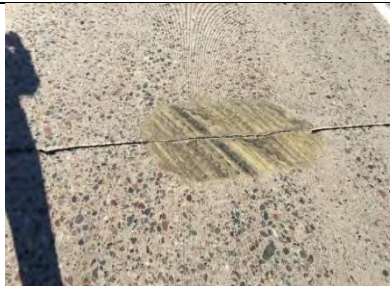
| Cell/Product/Location: 94004(A) – DS Brown, PaveSaver Polymeric Concrete Patch – Passing MLJ | | |

| 2018 Condition (Rating): No distress (4) | 2019 Condition (Rating): Debonded (3) | 2020 Condition (Rating): Debonded (3) |

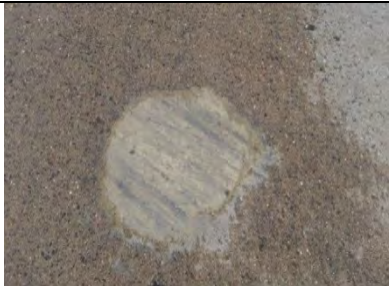
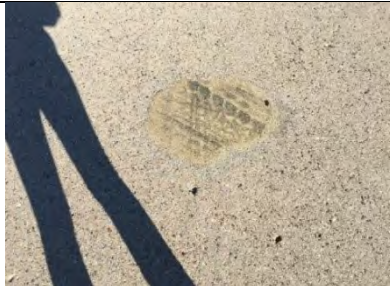
| Cell/Product/Location: 94004(A) – DS Brown, PaveSaver Polymeric Concrete Patch – Driving MLJ | | |

| 2018 Condition (Rating): No distress (4) | 2019 Condition (Rating): No distress (4) | 2020 Condition (Rating): No distress (4) |

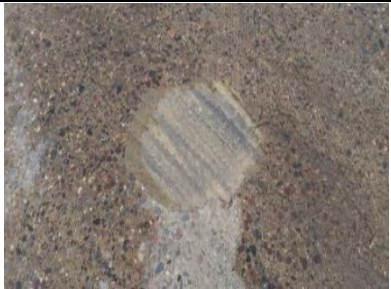
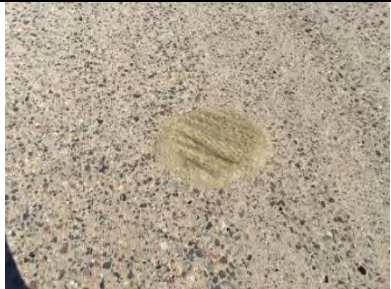
| Cell/Product/Location: 94004(A) – DS Brown, PaveSaver Polymeric Concrete Patch – Passing ML | | |

| 2018 Condition (Rating): No distress (4) | 2019 Condition (Rating): No distress (4) | 2020 Condition (Rating): No distress (4) |

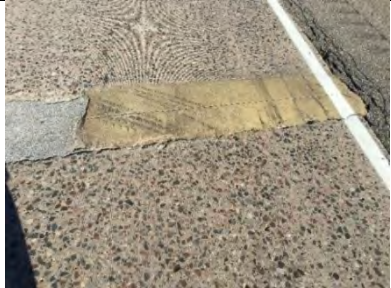
| Cell/Product/Location: 94004(A) – DS Brown, PaveSaver Polymeric Concrete Patch – Driving ML | | |

| 2018 Condition (Rating): No distress (4) | 2019 Condition (Rating): No distress (4) | 2020 Condition (Rating): No distress (4) |

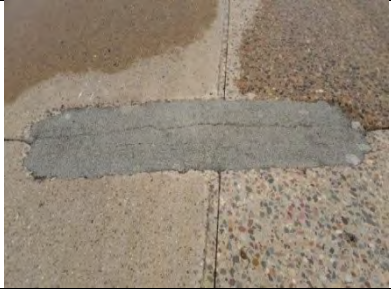
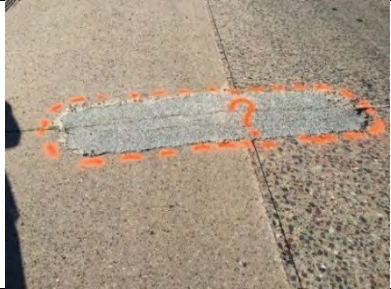
| Cell/Product/Location: 94004(A) – DS Brown, PaveSaver Polymeric Concrete Patch – Half of Driving FL | | |

| 2018 Condition (Rating): No distress (4) | 2019 Condition (Rating): Shrinkage cracks, debonded (3) | 2020 Condition (Rating): Linear cracks, <50% patch gone (2) |

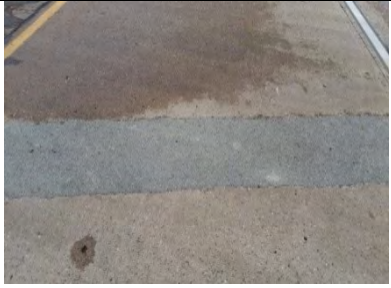
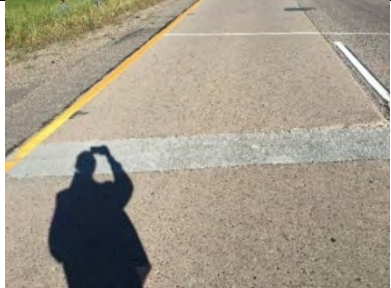
| Cell/Product/Location: 94004(B) – Crafcu, HP Concrete Cold Patch – WP | | |

| 2018 Condition (Rating): No distress (4) | 2019 Condition (Rating): Linear cracks, patch depressed (3) | 2020 Condition (Rating): Linear cracks, depressed patch, <50% patch gone (2) |

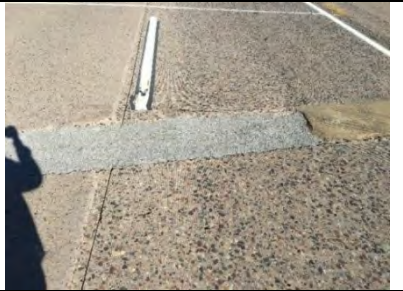
| Cell/Product/Location: 94004(B) – Crafcu, HP Concrete Cold Patch – Passing FL | | |

| 2018 Condition (Rating): No distress (4) | 2019 Condition (Rating): Linear cracks, patch depressed (3) | 2020 Condition (Rating): Linear cracks, depressed patch, <50% patch gone (2) |

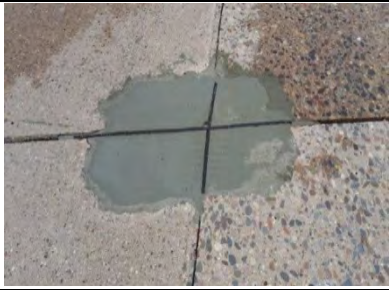
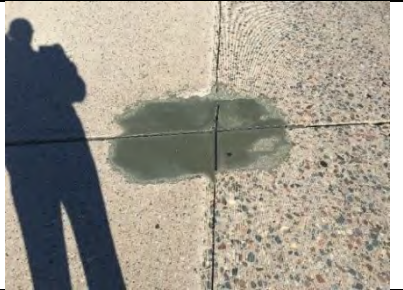
| Cell/Product/Location: 94004(B) – Crafcro, HP Concrete Cold Patch – Half of Driving FL | | |

| 2018 Condition (Rating): No distress (4) | 2019 Condition (Rating): Linear cracks, patch depressed (3) | 2020 Condition (Rating): Linear cracks, depressed patch, <50% patch gone (2) |

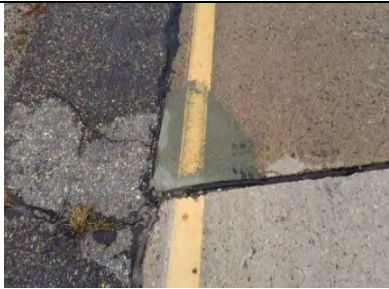
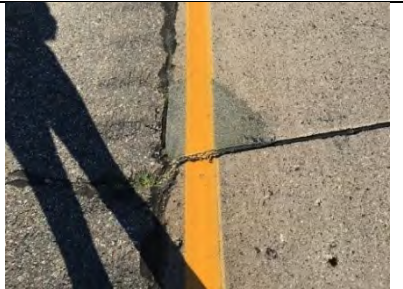
| Cell/Product/Location: 94005 – Willamette Valley Company, FastPatch DPR – CLJ | | |

| 2018 Condition (Rating): No distress (4) | 2019 Condition (Rating): No distress (4) | 2020 Condition (Rating): No distress (4) |

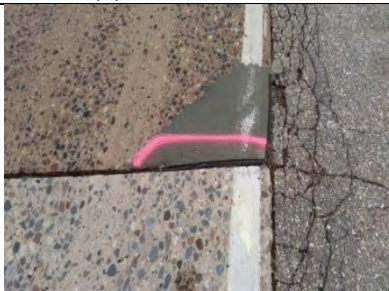
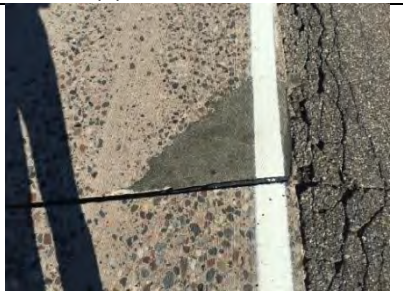
| Cell/Product/Location: 94005 – Willamette Valley Company, FastPatch DPR – Passing CP | | |

| 2018 Condition (Rating): No distress (4) | 2019 Condition (Rating): No distress (4) | 2020 Condition (Rating): No distress (4) |

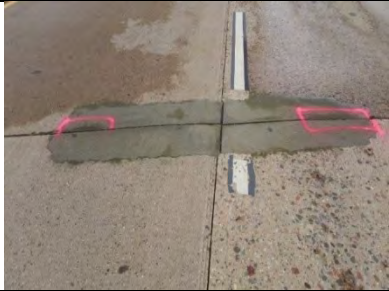
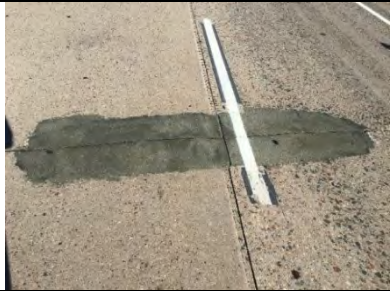
| Cell/Product/Location: 94005 – Willamette Valley Company, FastPatch DPR – Driving CP | | |

| 2018 Condition (Rating): No distress (4) | 2019 Condition (Rating): Linear cracks (3) | 2020 Condition (Rating): Linear cracks (3) |

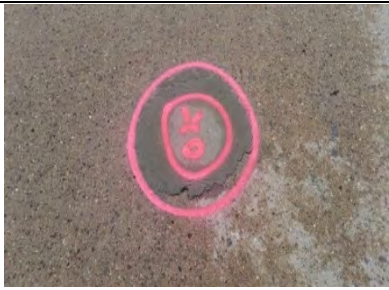
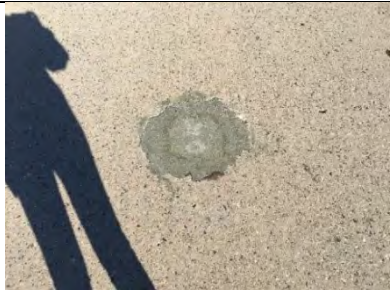
| Cell/Product/Location: 94005 – Willamette Valley Company, FastPatch DPR – WP | | |

| 2018 Condition (Rating): No distress (4) | 2019 Condition (Rating): Linear cracks (3) | 2020 Condition (Rating): Linear cracks (3) |

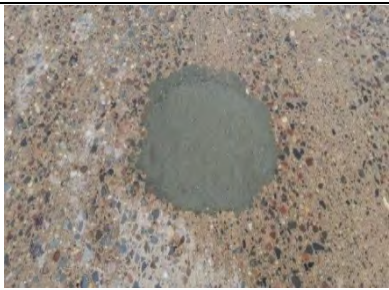
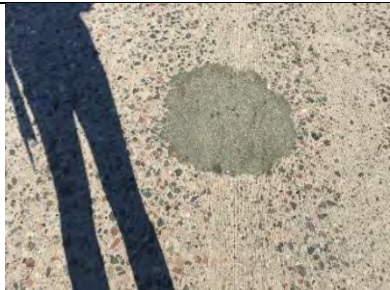
| Cell/Product/Location: 94005 – Willamette Valley Company, FastPatch DPR – Passing ML | | |

| 2018 Condition (Rating): No distress (4) | 2019 Condition (Rating): No distress (4) | 2020 Condition (Rating): No distress (4) |

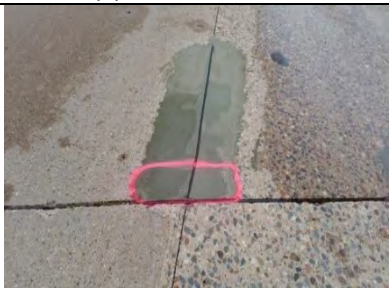
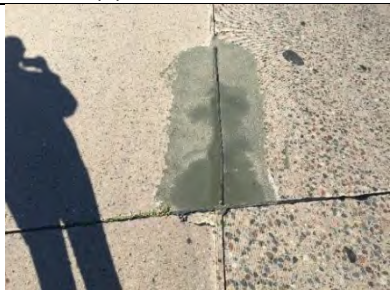
| Cell/Product/Location: 94005 – Willamette Valley Company, FastPatch DPR – Driving ML | | |

| 2018 Condition (Rating): No distress (4) | 2019 Condition (Rating): No distress (4) | 2020 Condition (Rating): No distress (4) |

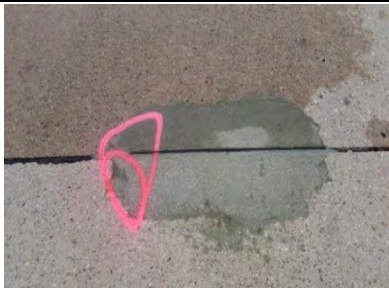
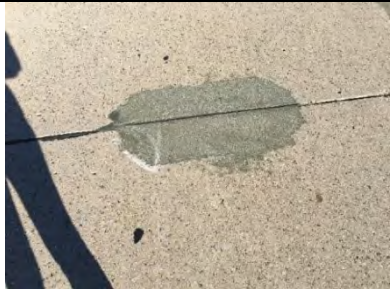
| Cell/Product/Location: 94005 – Willamette Valley Company, FastPatch DPR – CL | | |

| 2018 Condition (Rating): No distress (4) | 2019 Condition (Rating): Debonded (3) | 2020 Condition (Rating): Debonded (3) |
