# Effective Long-Lasting Partial Depth Joint Repairs for Challenging Conditions

NRRA PREVENTIVE MAINTENANCE TEAM

Report No. NRRA202104

| 16. Abstract (Limit: 250 words)<br><br>As Portland cement concrete (PCC) pavements age, longitudinal and transverse joints can exhibit signs of distress as a result of traffic loading, climatic variations, materials-related issues, and construction defects. Although only small areas are often involved, the joint distress can substantially disrupt traffic flow and increase pavement roughness, sacrificing consumer ride comfort. When immediate action is required, temporary repairs are often made using readily available materials, such as cold mix or other asphalt materials. These temporary materials are often replaced with more permanent materials to reestablish the integrity and functionality of the concrete pavement. The goal of this project is to provide a guide for agencies to establish an effective joint repair program. The final report reviews the background information explaining why this research was performed, summarizes the findings from previous similar research studies, details how the patches were constructed and how they performed, a

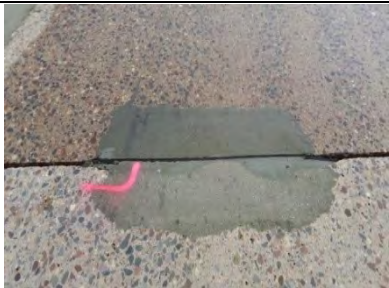
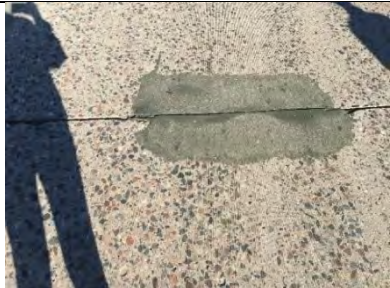
| Cell/Product/Location: 94005 – Willamette Valley Company, FastPatch DPR – Passing MLJ | | |

| 2018 Condition (Rating): No distress (4) | 2019 Condition (Rating): Linear cracks (3) | 2020 Condition (Rating): Linear cracks (3) |

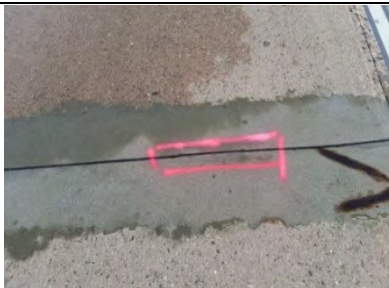
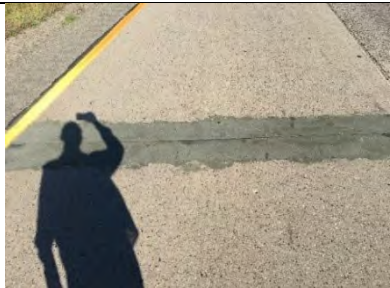
| Cell/Product/Location: 94005 – Willamette Valley Company, FastPatch DPR – Driving MLJ | | |

| 2018 Condition (Rating): No distress (4) | 2019 Condition (Rating): Linear cracks (3) | 2020 Condition (Rating): Linear cracks (3) |

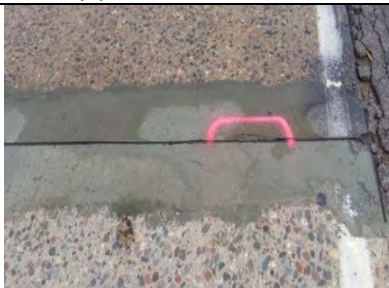
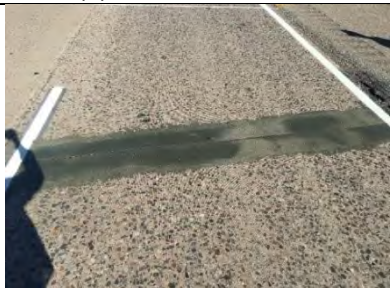
| Cell/Product/Location: 94005 – Willamette Valley Company, FastPatch DPR – Passing FL | | |

| 2018 Condition (Rating): No distress (4) | 2019 Condition (Rating): Linear cracks (3) | 2020 Condition (Rating): Linear cracks (3) |

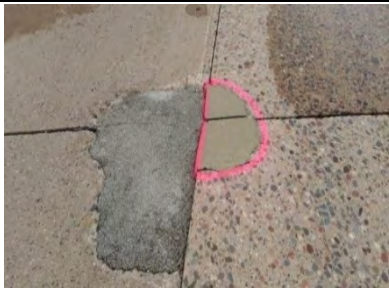
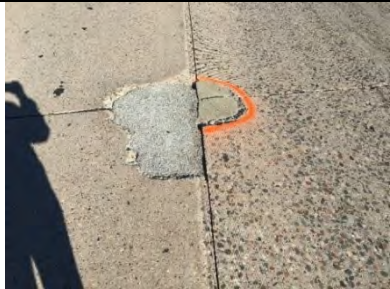
| Cell/Product/Location: 94005 – Willamette Valley Company, FastPatch DPR – Driving FL | | |

| 2018 Condition (Rating): No distress (4) | 2019 Condition (Rating): Linear cracks (3) | 2020 Condition (Rating): Linear cracks (3) |

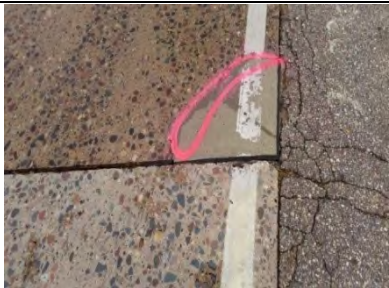
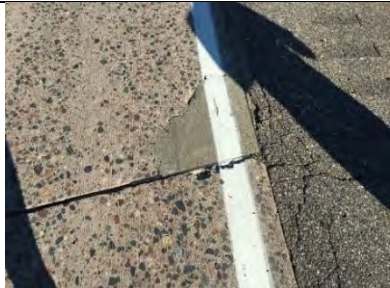
| Cell/Product/Location: 94006(A) – Five Star Products, Rapid Surface Repair Easy Mix – CLJ | | |

| 2018 Condition (Rating): No distress (4) | 2019 Condition (Rating): >50% patch gone (1) | 2020 Condition (Rating): Linear cracks, >50% patch gone (1) |

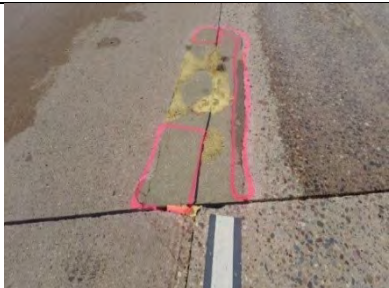
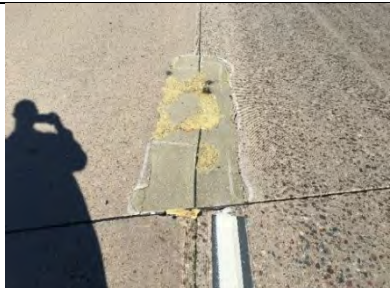
| Cell/Product/Location: 94006(A) – Five Star Products, Rapid Surface Repair Easy Mix – Driving CP | | |

| 2018 Condition (Rating): No distress (4) | 2019 Condition (Rating): Linear cracks (3) | 2020 Condition (Rating): Linear cracks (3) |

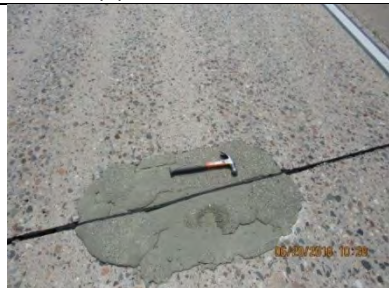
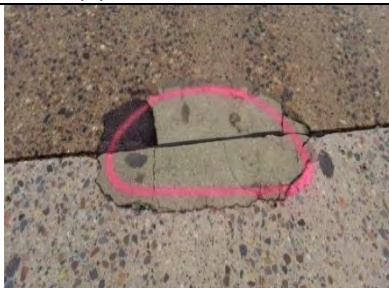
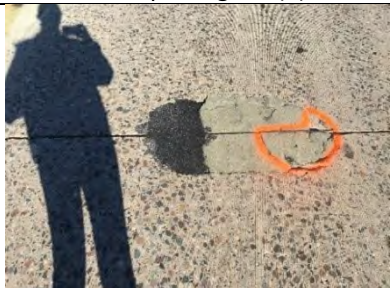
| Cell/Product/Location: 94006(A) – Five Star Products, Rapid Surface Repair Easy Mix – CL | | |

| 2018 Condition (Rating): No distress (4) | 2019 Condition (Rating): Linear cracks (3) | 2020 Condition (Rating): Linear cracks, <50% patch gone (2) |

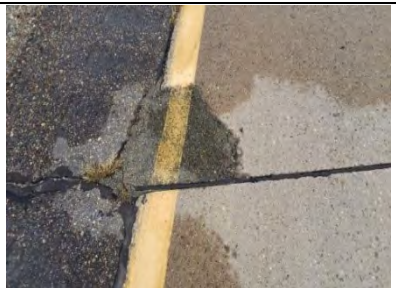
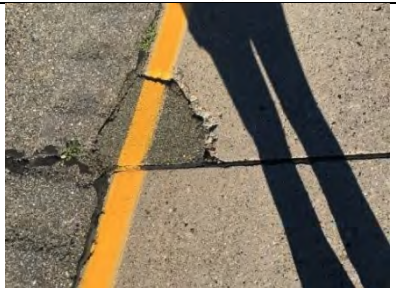
| Cell/Product/Location: 94006(B) – Five Star Products, Rapid Surface Repair Epoxy Fix – Passing CP | | |

| 2018 Condition (Rating): No distress (4) | 2019 Condition (Rating): Linear cracks (3) | 2020 Condition (Rating): Linear cracks, <50% patch gone (2) |

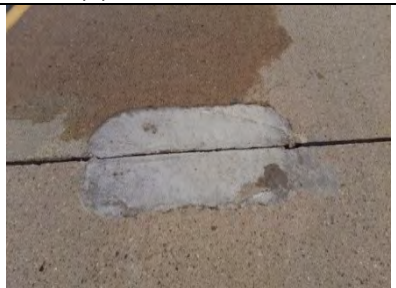
| 2018 Condition (Rating): No distress (4) | 2019 Condition (Rating): Linear cracks (3) | 2020 Condition (Rating): Linear cracks (3) |

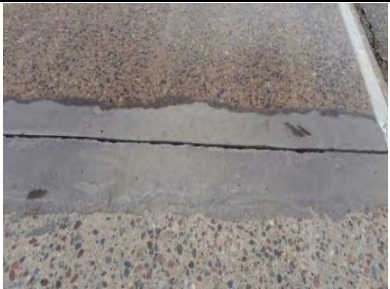
| Cell/Product/Location: 94007 – TCC Materials, ProSpec Concrete Patching Mix – Passing FL | | |

| 2018 Condition (Rating): <50% patch gone (2) | 2019 Condition (Rating): Linear cracks, >50% patch gone (1) | 2020 Condition (Rating): Linear cracks, >50% patch gone (1) |

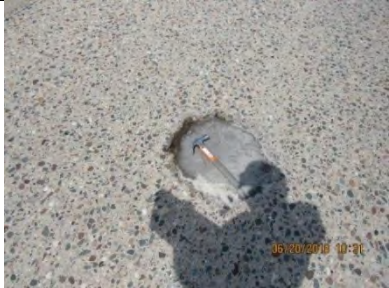
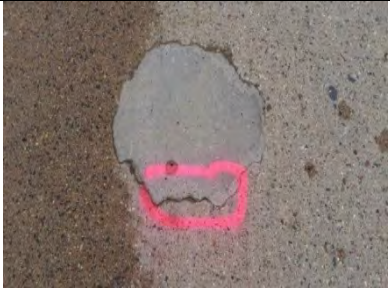
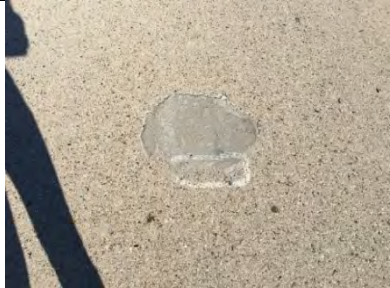
| Cell/Product/Location: 94007 – TCC Materials, ProSpec Concrete Patching Mix – Driving FL | | |

| 2018 Condition (Rating): No distress (4) | 2019 Condition (Rating): Shrinkage cracks (4) | 2020 Condition (Rating): Shrinkage cracks (4) |

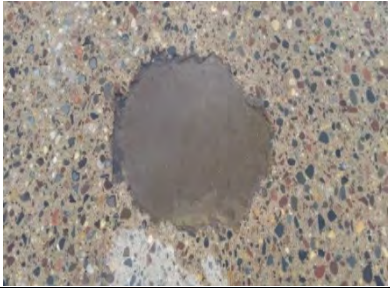
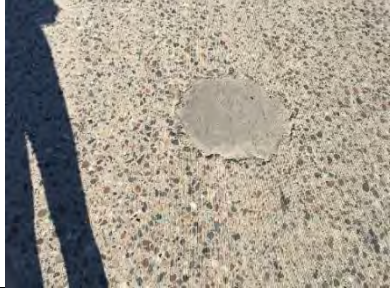
| Cell/Product/Location: 94007 – TCC Materials, ProSpec Concrete Patching Mix – Passing ML | | |

| 2018 Condition (Rating): No distress (4) | 2019 Condition (Rating): Debonded (3) | 2020 Condition (Rating): Debonded (3) |

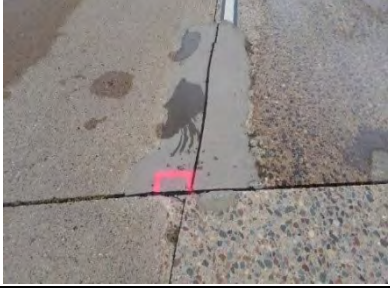
| Cell/Product/Location: 94007 – TCC Materials, ProSpec Concrete Patching Mix – Driving ML | | |

| 2018 Condition (Rating): No distress (4) | 2019 Condition (Rating): 100% patch gone (0) | 2020 Condition (Rating): 100% patch gone (0) |

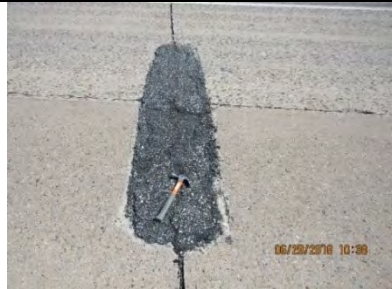
| Cell/Product/Location: 94008(A) – Aqua Patch Road Materials, Aqua Patch – Passing ML | | |

| 2018 Condition (Rating): No distress (4) | 2019 Condition (Rating): <50% patch gone (2) | 2020 Condition (Rating): 100% patch gone (0) |

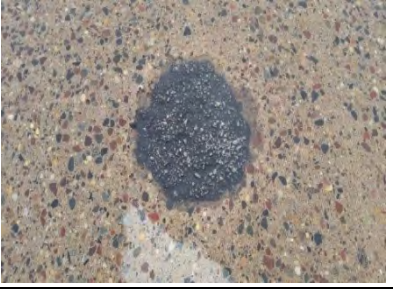
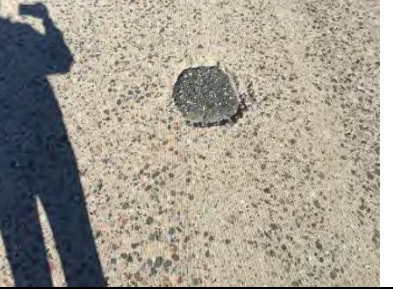
| Cell/Product/Location: 94008(A) – Aqua Patch Road Materials, Aqua Patch – Driving ML | | |

| 2018 Condition (Rating): Linear cracks, <50% patch gone (2) | 2019 Condition (Rating): 100% patch gone (0) | 2020 Condition (Rating): 100% patch gone (0) |

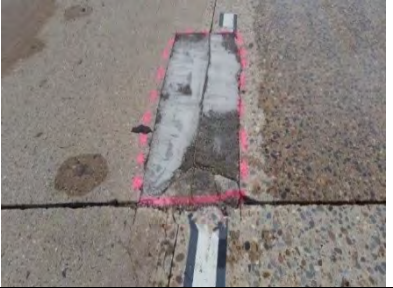
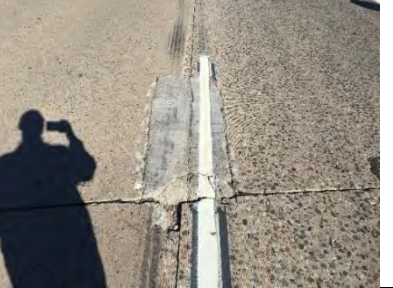
| 2018 Condition (Rating): No distress (4) | 2019 Condition (Rating): <50% patch gone (2) | 2020 Condition (Rating): >50% patch gone (1) |

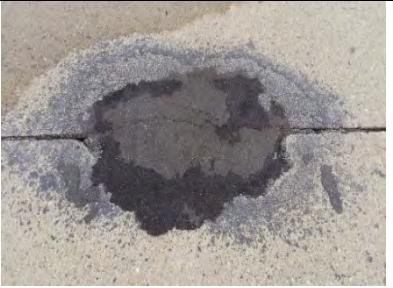
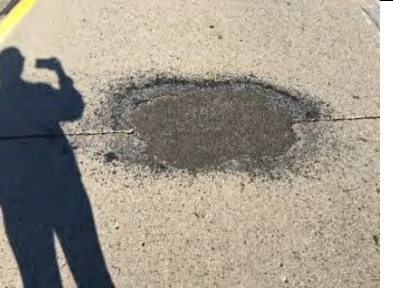
| Cell/Product/Location: 94008(A) – Aqua Patch Road Materials, Aqua Patch – CL | | |

| 2018 Condition (Rating): Linear cracks (3) | 2019 Condition (Rating): 100% patch gone (0) | 2020 Condition (Rating): 100% patch gone (0) |

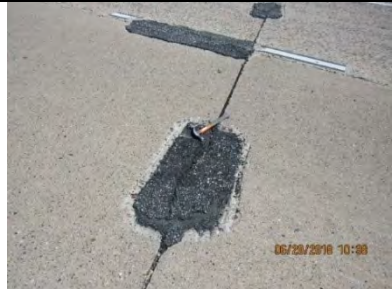
| Cell/Product/Location: 94008(A) – Aqua Patch Road Materials, Aqua Patch – Passing MLJ | | |

| 2018 Condition (Rating): Linear cracks, <50% patch gone (2) | 2019 Condition (Rating): >50% of patch gone (1) | 2020 Condition (Rating): 100% patch gone (0) |

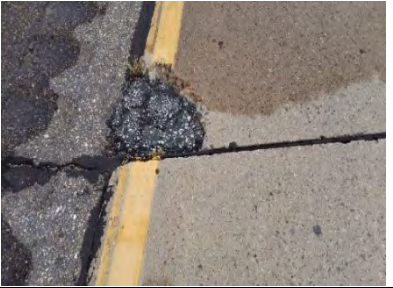
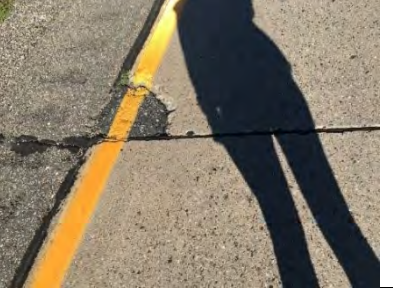
| Cell/Product/Location: 94008(A) – Aqua Patch Road Materials, Aqua Patch – CLJ | | |

| 2018 Condition (Rating): No distress (4) | 2019 Condition (Rating): 100% patch gone (0) | 2020 Condition (Rating): 100% patch gone (0) |

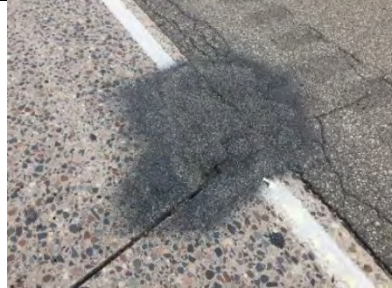
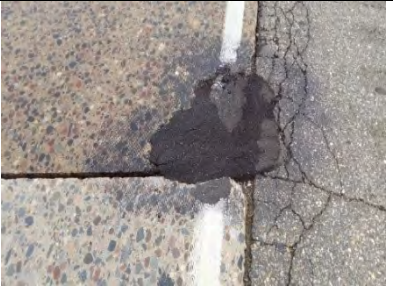
| Cell/Product/Location: 94008(A) – Aqua Patch Road Materials, Aqua Patch – Passing CP | | |

| 2018 Condition (Rating): No distress (4) | 2019 Condition (Rating): Linear cracks, <50% patch gone (2) | 2020 Condition (Rating): Linear cracks, <50% patch gone (2) |

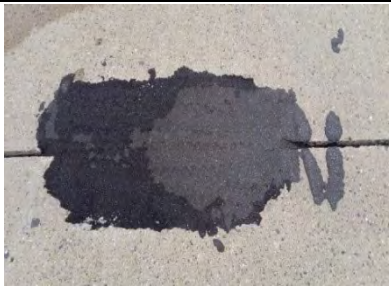
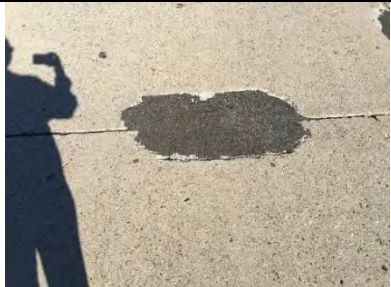
| Cell/Product/Location: 94009 – Crafc0, HP Concrete Cold Patch – CL | | |

| 2018 Condition (Rating): No distress (4) | 2019 Condition (Rating): >50% patch overlaid with HMA (1) | 2020 Condition (Rating): >50% patch overlaid with HMA (1) |

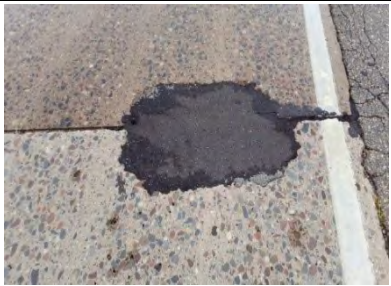
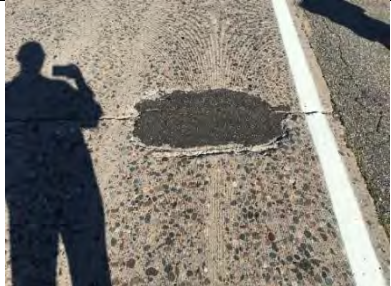
| Cell/Product/Location: 94009 – Crafc0, HP Concrete Cold Patch – Passing MLJ | | |

| 2018 Condition (Rating): No distress (4) | 2019 Condition (Rating): >50% patch overlaid with HMA (1) | 2020 Condition (Rating): >50% patch overlaid with HMA (1) |

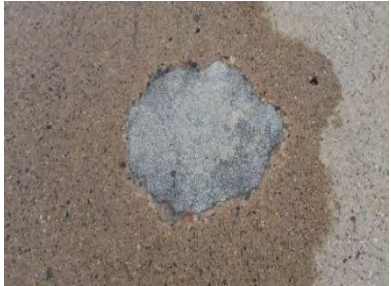
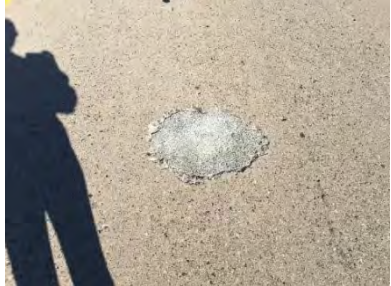
| Cell/Product/Location: 94009 – Crafc0, HP Concrete Cold Patch – Driving MLJ | | |

| 2018 Condition (Rating): No distress (4) | 2019 Condition (Rating): >50% patch overlaid with HMA (1) | 2020 Condition (Rating): >50% patch overlaid with HMA (1) |

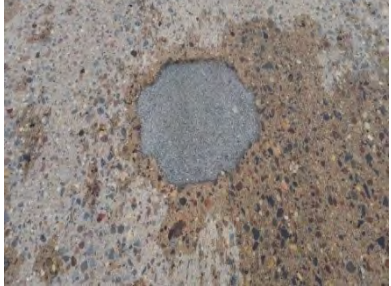
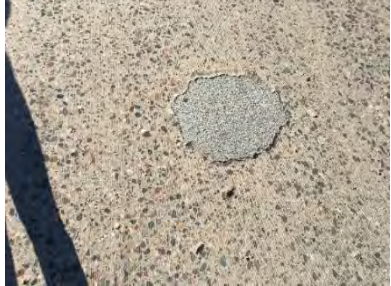
| Cell/Product/Location: 94009 – Crafc0, HP Concrete Cold Patch – Passing ML | | |

| 2018 Condition (Rating): No distress (4) | 2019 Condition (Rating): No distress (4) | 2020 Condition (Rating): No distress (4) |

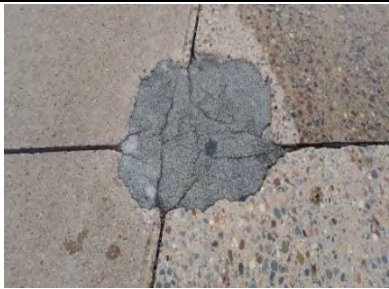
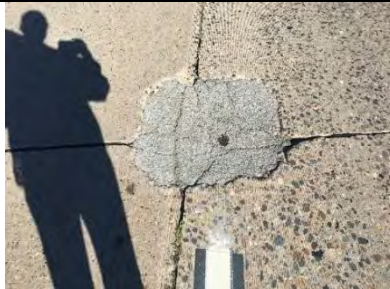
| Cell/Product/Location: 94009 – Crafc0, HP Concrete Cold Patch – Driving ML | | |

| 2018 Condition (Rating): No distress (4) | 2019 Condition (Rating): No distress (4) | 2020 Condition (Rating): No distress (4) |

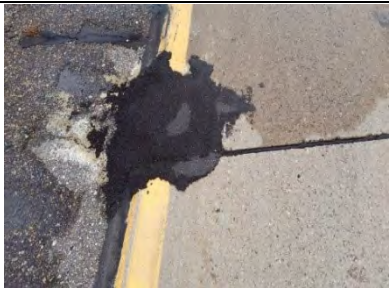
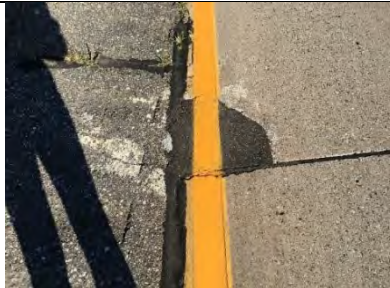
| Cell/Product/Location: 94009 – Crafc0, HP Concrete Cold Patch – CLJ | | |

| 2018 Condition (Rating): No distress (4) | 2019 Condition (Rating): Linear cracking, patch depressed (3) | 2020 Condition (Rating): Linear cracks, depressed patch (3) |

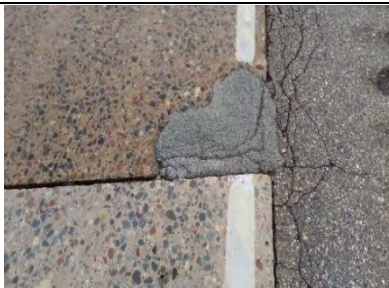
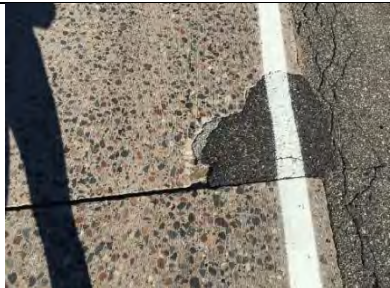
| Cell/Product/Location: 94009 – Crafc0, HP Concrete Cold Patch – Passing CP | | |

| 2018 Condition (Rating): No distress (4) | 2019 Condition (Rating): >50% patch overlaid with HMA (1) | 2020 Condition (Rating): >50% patch overlaid with HMA (1) |

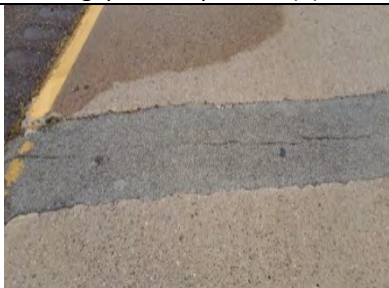
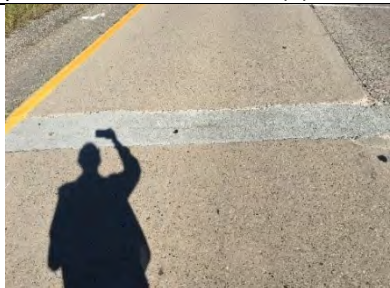
| Cell/Product/Location: 94009 – Crafc0, HP Concrete Cold Patch – Driving CP | | |

| 2018 Condition (Rating): No distress (4) | 2019 Condition (Rating): Linear cracking, patch depressed (3) | 2020 Condition (Rating): >50% patch overlaid with HMA (1) |

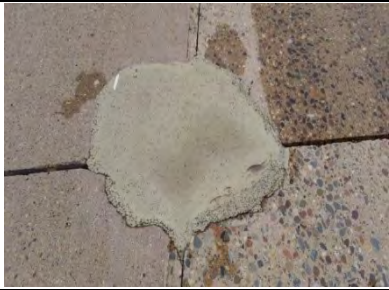
| Cell/Product/Location: 94009 – Crafc0, HP Concrete Cold Patch – Driving FL | | |

| 2018 Condition (Rating): No distress (4) | 2019 Condition (Rating): Linear cracking, patch depressed (3) | 2020 Condition (Rating): Linear cracks, depressed patch, <50% patch gone (2) |

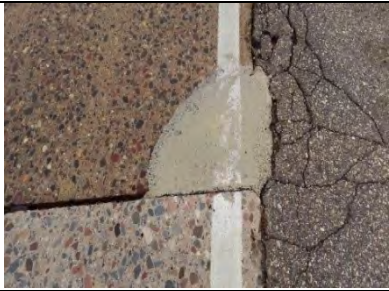
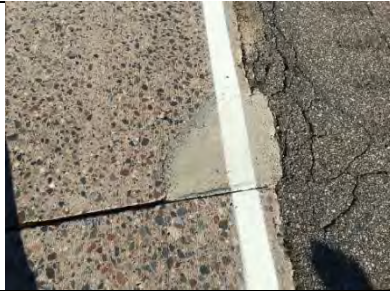
| Cell/Product/Location: 94010 – Crafc0, Techrete-TBR – Passing CP | | |

| 2018 Condition (Rating): No distress (4) | 2019 Condition (Rating): No distress (4) | 2020 Condition (Rating): No distress (4) |

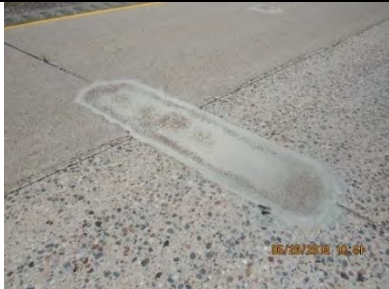
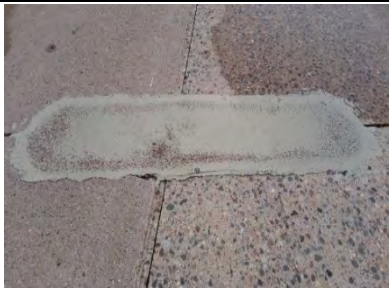
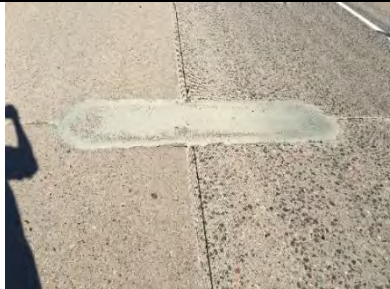
| Cell/Product/Location: 94010 – Crafc0, Techrete-TBR – Driving CP | | |

| 2018 Condition (Rating): No distress (4) | 2019 Condition (Rating): No distress (4) | 2020 Condition (Rating): No distress (4) |

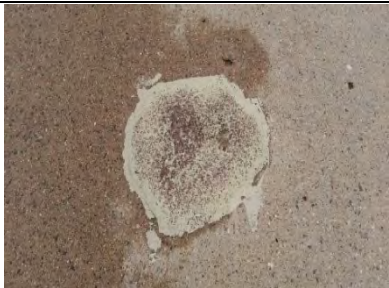
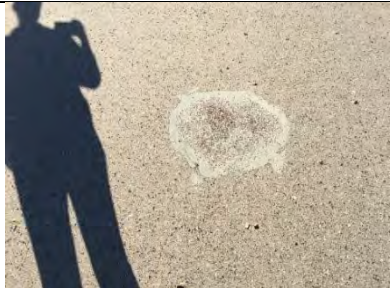
| Cell/Product/Location: 94010 – Crafc0, Techrete-TBR – WP | | |

| 2018 Condition (Rating): No distress (4) | 2019 Condition (Rating): No distress (4) | 2020 Condition (Rating): No distress (4) |

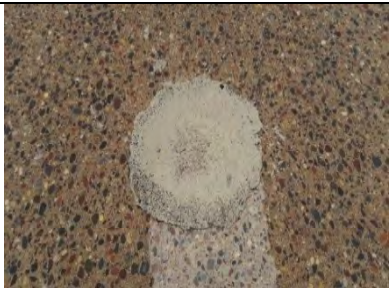
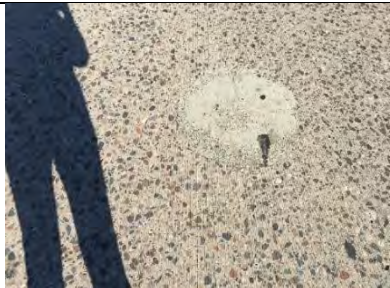
| Cell/Product/Location: 94010 – Crafc0, Techrete-TBR – Passing ML | | |

| 2018 Condition (Rating): No distress (4) | 2019 Condition (Rating): No distress (4) | 2020 Condition (Rating): No distress (4) |

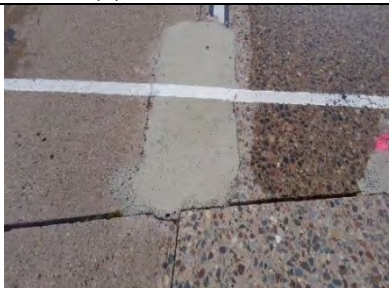
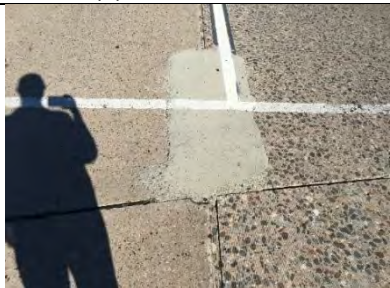
| Cell/Product/Location: 94010 – Crafc0, Techrete-TBR – Driving ML | | |

| 2018 Condition (Rating): No distress (4) | 2019 Condition (Rating): No distress (4) | 2020 Condition (Rating): No distress (4) |

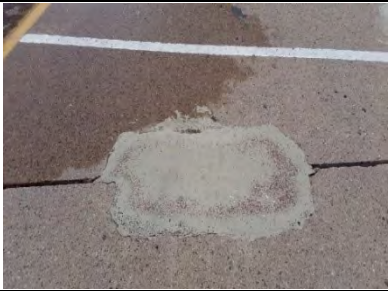
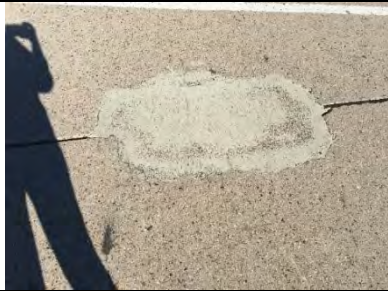
| Cell/Product/Location: 94010 – Crafc0, Techrete-TBR – CL | | |

| 2018 Condition (Rating): No distress (4) | 2019 Condition (Rating): No distress (4) | 2020 Condition (Rating): No distress (4) |

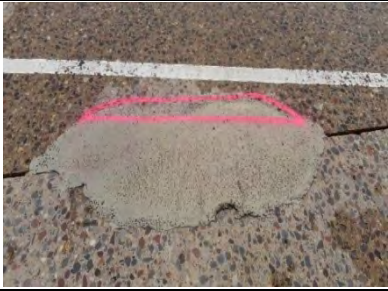
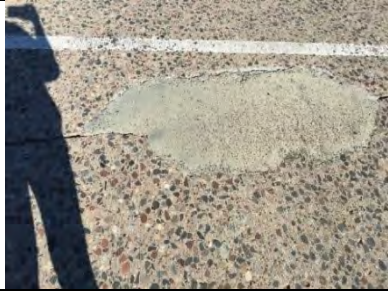
| Cell/Product/Location: 94010 – Crafc0, Techrete-TBR – Passing MLJ | | |

| 2018 Condition (Rating): No distress (4) | 2019 Condition (Rating): No distress (4) | 2020 Condition (Rating): No distress (4) |

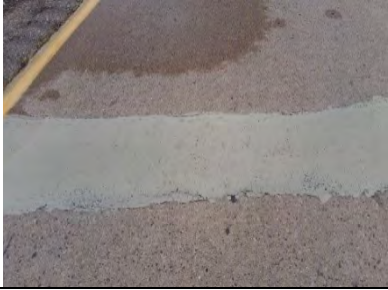
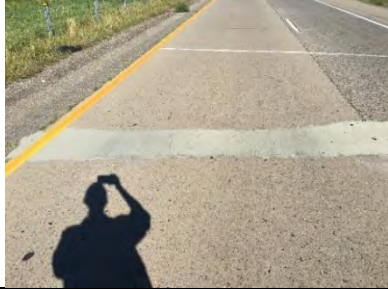
| Cell/Product/Location: 94010 – Crafc0, Techrete-TBR – Driving MLJ | | |

| 2018 Condition (Rating): No distress (4) | 2019 Condition (Rating): Debonded (3) | 2020 Condition (Rating): Debonded (3) |

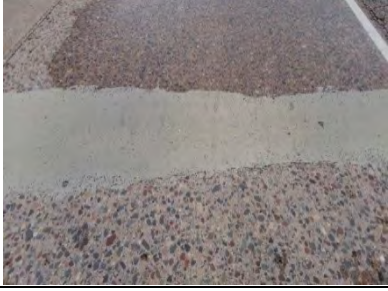
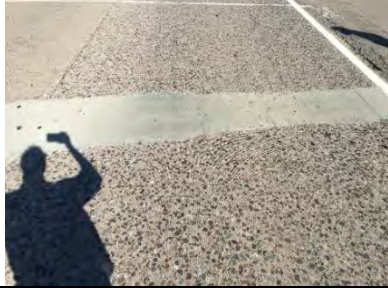
| Cell/Product/Location: 94010 – Crafc0, Techrete-TBR – Passing FL | | |

| 2018 Condition (Rating): No distress (4) | 2019 Condition (Rating): No distress (4) | 2020 Condition (Rating): No distress (4) |

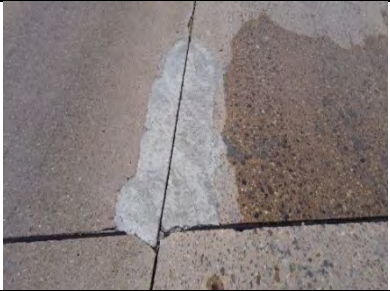
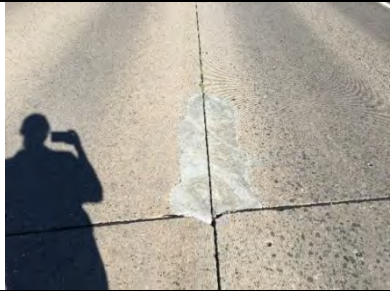
| Cell/Product/Location: 94010 – Crafc0, Techrete-TBR – Driving FL | | |

| 2018 Condition (Rating): No distress (4) | 2019 Condition (Rating): No distress (4) | 2020 Condition (Rating): No distress (4) |

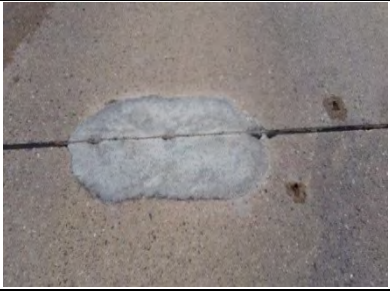
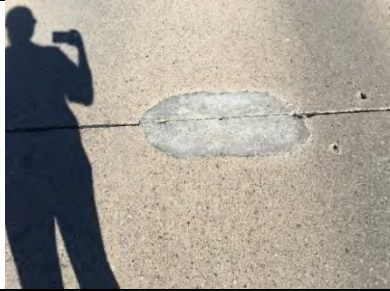
| Cell/Product/Location: 94011 – TCC Materials, 3U18 Modified – CL | | |

| 2018 Condition (Rating): No distress (4) | 2019 Condition (Rating): No distress (4) | 2020 Condition (Rating): No distress (4) |

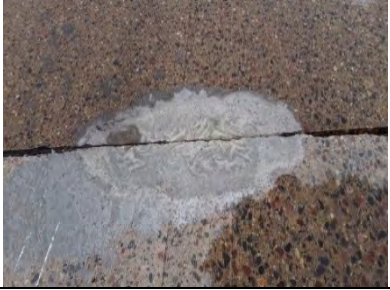
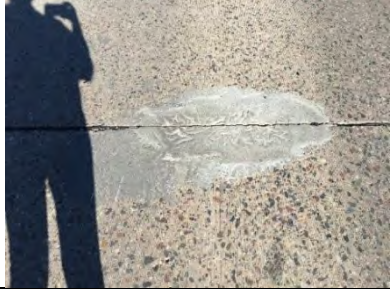
| Cell/Product/Location: 94011 – TCC Materials, 3U18 Modified – Passing MLJ | | |

| 2018 Condition (Rating): No distress (4) | 2019 Condition (Rating): No distress (4) | 2020 Condition (Rating): No distress (4) |

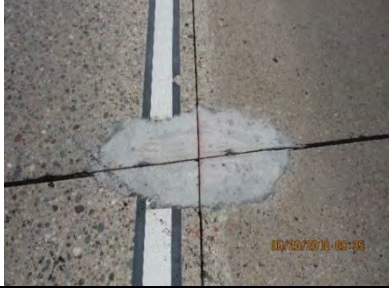
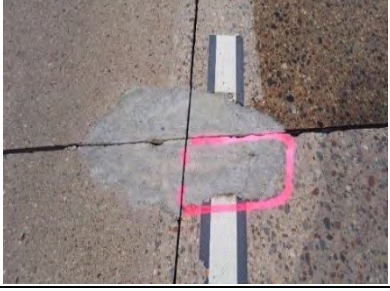
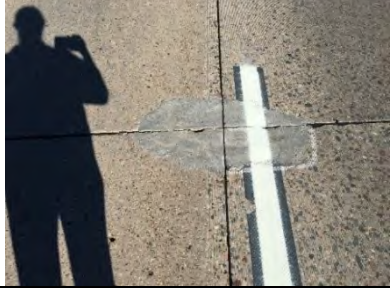
| Cell/Product/Location: 94011 – TCC Materials, 3U18 Modified – Driving MLJ | | |

| 2018 Condition (Rating): No distress (4) | 2019 Condition (Rating): No distress (4) | 2020 Condition (Rating): No distress (4) |

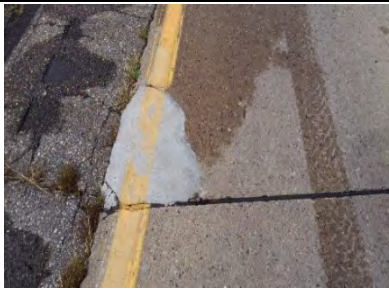
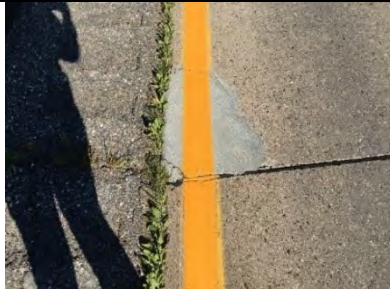
| Cell/Product/Location: 94011 – TCC Materials, 3U18 Modified – CLJ | | |

| 2018 Condition (Rating): No distress (4) | 2019 Condition (Rating): Shrinkage cracks, debonded (3) | 2020 Condition (Rating): Linear cracks, debonded (3) |

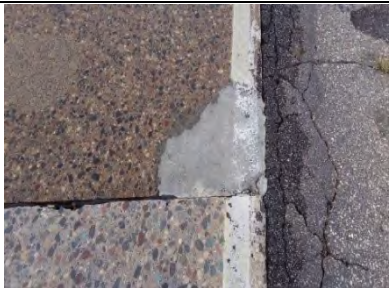
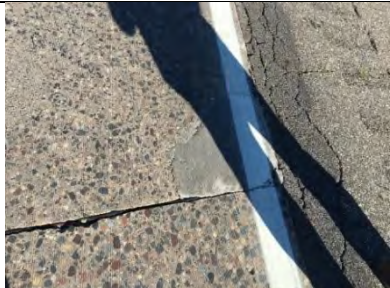
| Cell/Product/Location: 94011 – TCC Materials, 3U18 Modified – Passing CP | | |

| 2018 Condition (Rating): No distress (4) | 2019 Condition (Rating): Linear cracks (3) | 2020 Condition (Rating): Linear cracks (3) |

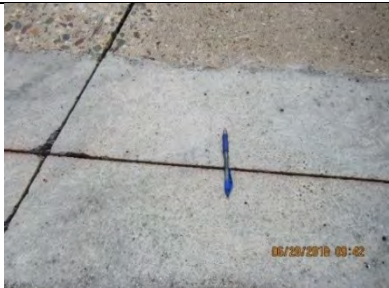
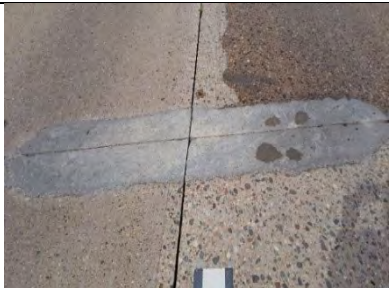
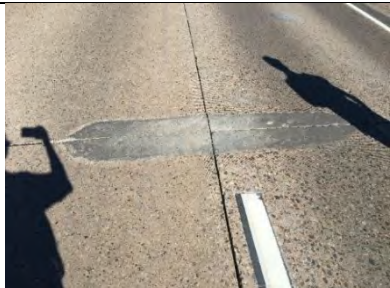
| Cell/Product/Location: 94011 – TCC Materials, 3U18 Modified – Driving CP | | |

| 2018 Condition (Rating): No distress (4) | 2019 Condition (Rating): Linear cracks (3) | 2020 Condition (Rating): Linear cracks (3) |

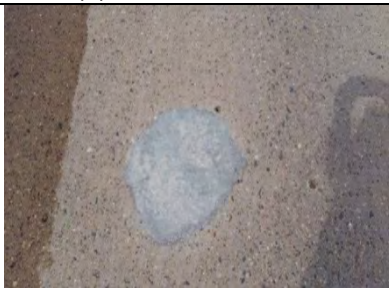
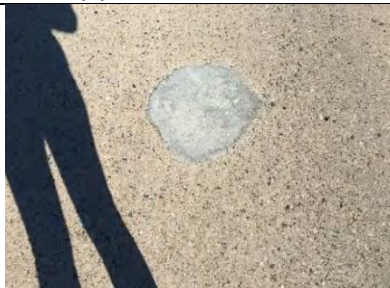
| Cell/Product/Location: 94011 – TCC Materials, 3U18 Modified – WP | | |

| 2018 Condition (Rating): No distress (4) | 2019 Condition (Rating): Shrinkage cracks (4) | 2020 Condition (Rating): Shrinkage cracks (4) |

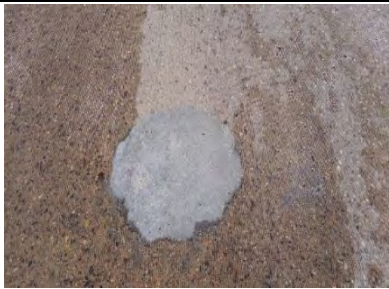
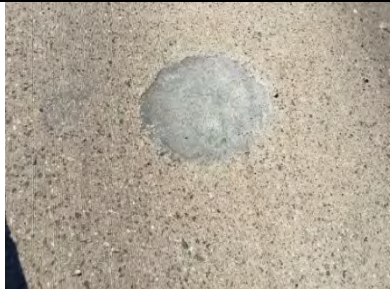
| Cell/Product/Location: 94011 – TCC Materials, 3U18 Modified – Passing ML | | |

| 2018 Condition (Rating): No distress (4) | 2019 Condition (Rating): Shrinkage cracks (4) | 2020 Condition (Rating): Shrinkage cracks (4) |

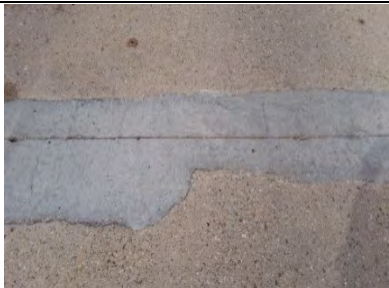
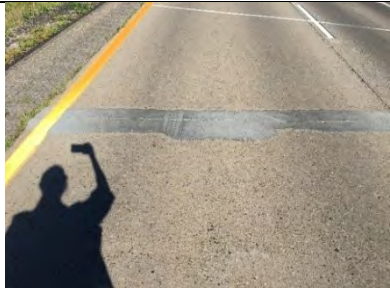
| Cell/Product/Location: 94011 – TCC Materials, 3U18 Modified – Driving ML | | |

| 2018 Condition (Rating): No distress (4) | 2019 Condition (Rating): Shrinkage cracks (4) | 2020 Condition (Rating): Shrinkage cracks (4) |

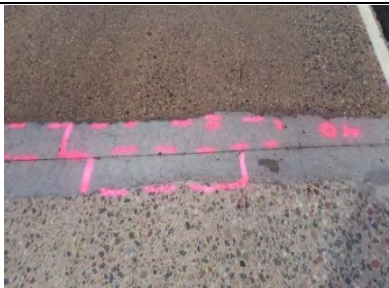
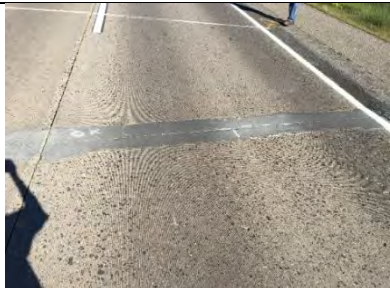
| Cell/Product/Location: 94011 – TCC Materials, 3U18 Modified – Passing FL | | |

| 2018 Condition (Rating): No distress (4) | 2019 Condition (Rating): Shrinkage cracks (4) | 2020 Condition (Rating): Shrinkage cracks (4) |

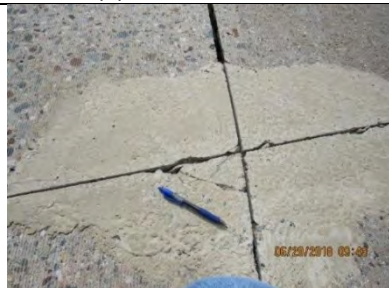
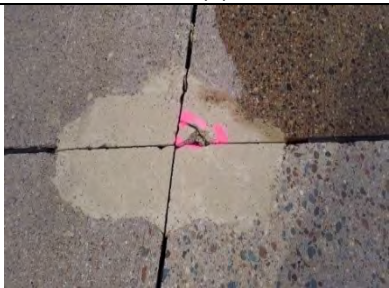
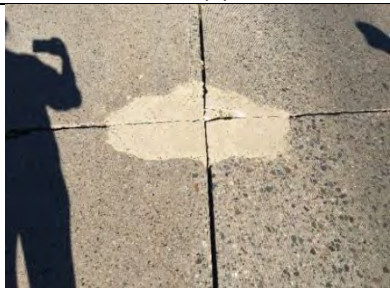
| Cell/Product/Location: 94011 – TCC Materials, 3U18 Modified – Driving FL | | |

| 2018 Condition (Rating): No distress (4) | 2019 Condition (Rating): Shrinkage cracks, debonded (3) | 2020 Condition (Rating): Shrinkage cracks, debonded (3) |

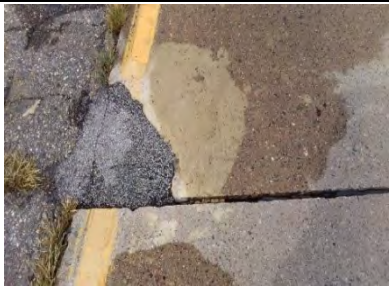
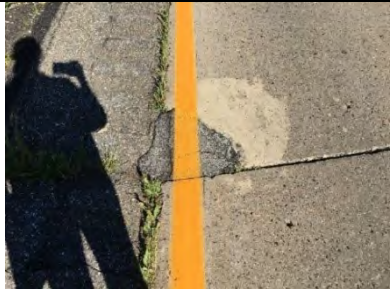
| Cell/Product/Location: 94012 – USG, Ecofix – CLJ | | |

| 2018 Condition (Rating): Linear cracks (3) | 2019 Condition (Rating): Linear cracks (3) | 2020 Condition (Rating): Linear cracks, <50% patch gone (2) |

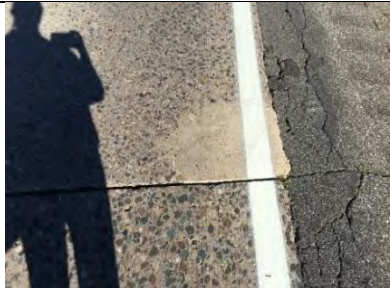
| Cell/Product/Location: 94012 – USG, Ecofix – Passing CP | | |

| 2018 Condition (Rating): No distress (4) | 2019 Condition (Rating): >50% patch gone (3) | 2020 Condition (Rating): 100% patch gone (0) |

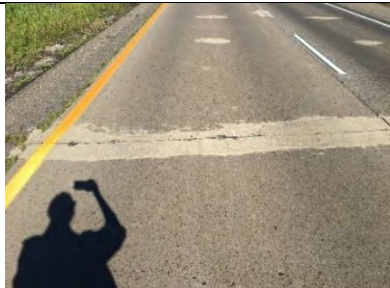
| Cell/Product/Location: 94012 – USG, Ecofix – Driving CP | | |

| 2018 Condition (Rating): No distress (4) | 2019 Condition (Rating): Shrinkage cracks (4) | 2020 Condition (Rating): Shrinkage cracks (4) |

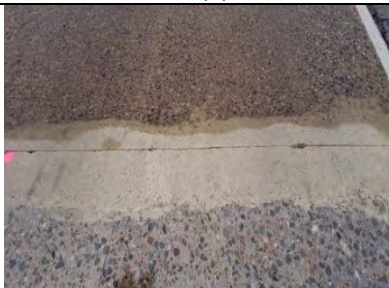
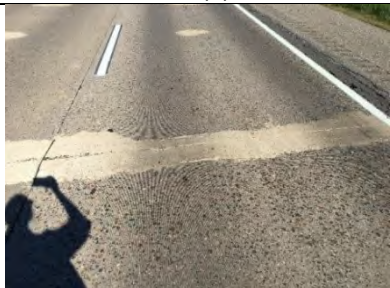
| Cell/Product/Location: 94012 – USG, Ecofix – Passing FL | | |

| 2018 Condition (Rating): No distress (4) | 2019 Condition (Rating): Shrinkage cracks, debonded (3) | 2020 Condition (Rating): Shrinkage cracks, debonded (3) |

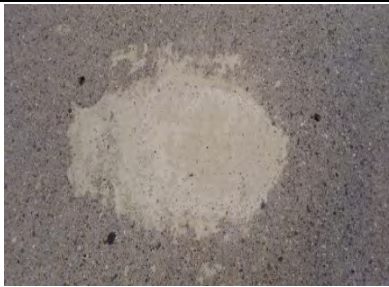
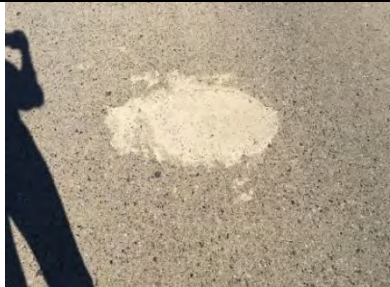
| Cell/Product/Location: 94012 – USG, Ecofix – Driving FL | | |

| 2018 Condition (Rating): No distress (4) | 2019 Condition (Rating): Shrinkage and linear cracks (3) | 2020 Condition (Rating): Linear cracks, <50% patch gone (2) |

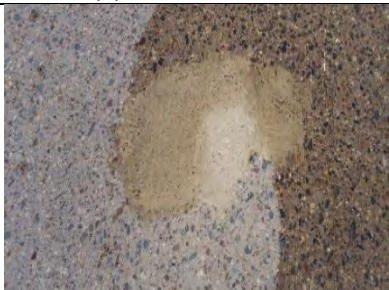
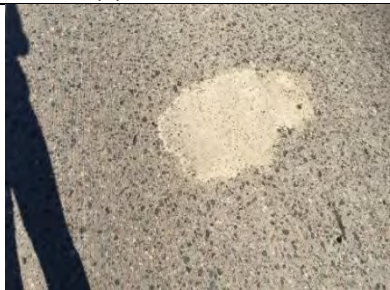
| Cell/Product/Location: 94012 – USG, Ecofix – Passing ML | | |

| 2018 Condition (Rating): No distress (4) | 2019 Condition (Rating): No distress (4) | 2020 Condition (Rating): No distress (4) |

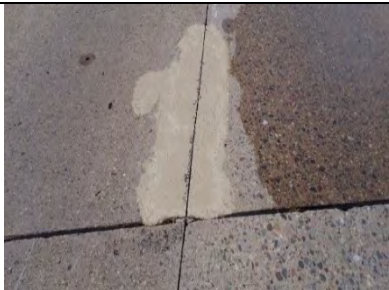
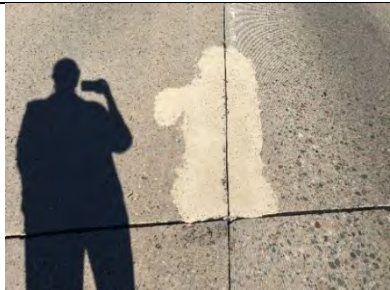
| Cell/Product/Location: 94012 – USG, Ecofix – Driving ML | | |

| 2018 Condition (Rating): No distress (4) | 2019 Condition (Rating): No distress (4) | 2020 Condition (Rating): No distress (4) |

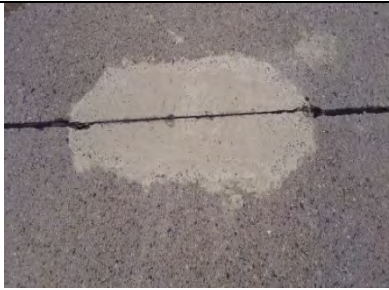
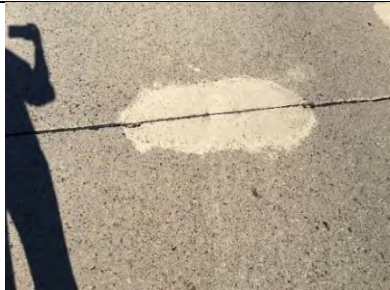
| Cell/Product/Location: 94012 – USG, Ecofix – CL | | |

| 2018 Condition (Rating): No distress (4) | 2019 Condition (Rating): No distress (4) | 2020 Condition (Rating): No distress (4) |

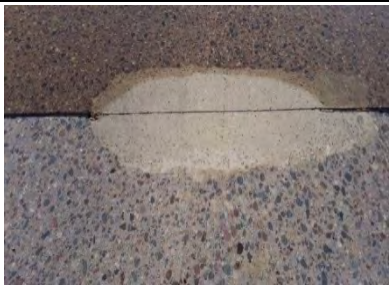
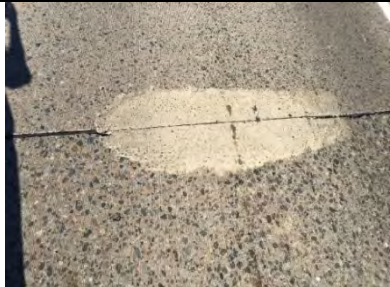
| Cell/Product/Location: 94012 – USG, Ecofix – Passing MLJ | | |

| 2018 Condition (Rating): No distress (4) | 2019 Condition (Rating): No distress (4) | 2020 Condition (Rating): No distress (4) |

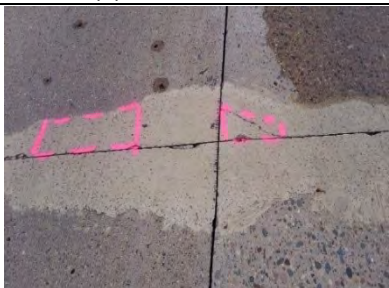
| Cell/Product/Location: 94012 – USG, Ecofix – Driving MLJ | | |

| 2018 Condition (Rating): No distress (4) | 2019 Condition (Rating): No distress (4) | 2020 Condition (Rating): No distress (4) |

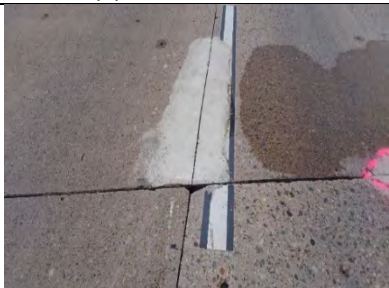
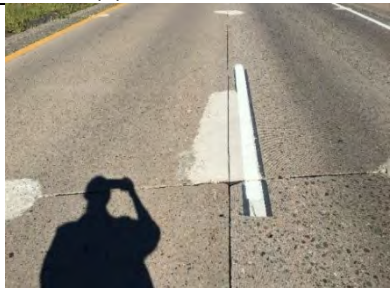
| Cell/Product/Location: 94013(A) – CTS, Rapid Set DOT Repair Mix w/Helix 5-25-Standard BA (Zinc Coated) Fibers – Driving FL | | |

| 2018 Condition (Rating): No distress (4) | 2019 Condition (Rating): No distress (4) | 2020 Condition (Rating): No distress (4) |

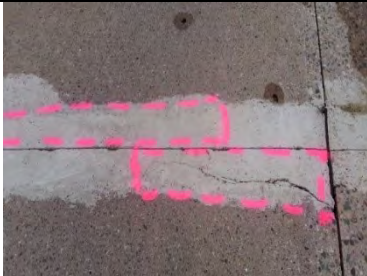
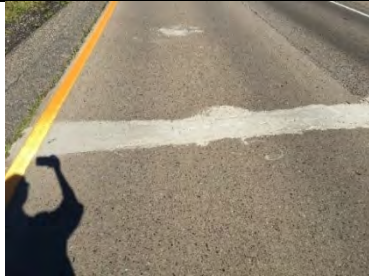
| Cell/Product/Location: 94013(A) – CTS, Rapid Set DOT Repair Mix w/Helix 5-25-Standard BA (Zinc Coated) Fibers – Driving WP | | |

| 2018 Condition (Rating): Linear cracks (3) | 2019 Condition (Rating): Linear cracks (3) | 2020 Condition (Rating): Linear cracks (3) |

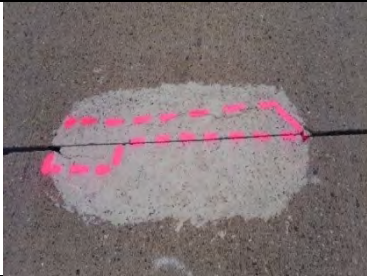
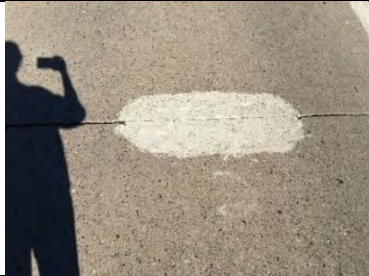
| Cell/Product/Location: 94013(B) – CTS, Rapid Set DOT Repair Mix w/Helix 5-25-SS BA (Stainless Steel) Fibers – Passing FL | | |

| 2018 Condition (Rating): No distress (4) | 2019 Condition (Rating): Linear cracks (3) | 2020 Condition (Rating): Linear cracks (3) |

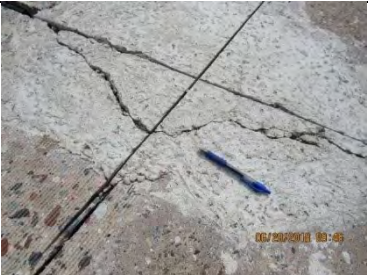
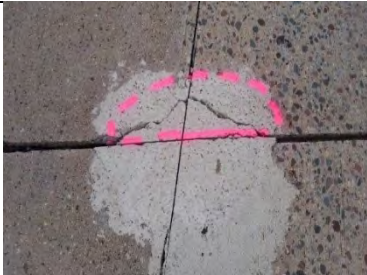
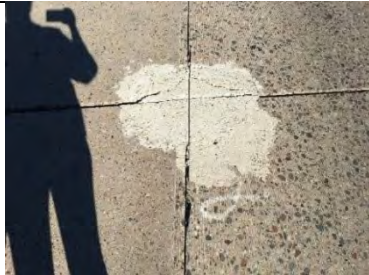
| Cell/Product/Location: 94013(B) – CTS, Rapid Set DOT Repair Mix w/Helix 5-25-SS BA (Stainless Steel) Fibers – Passing MLJ | | |

| 2018 Condition (Rating): No distress (4) | 2019 Condition (Rating): Shrinkage and linear cracks (3) | 2020 Condition (Rating): Linear cracks (3) |

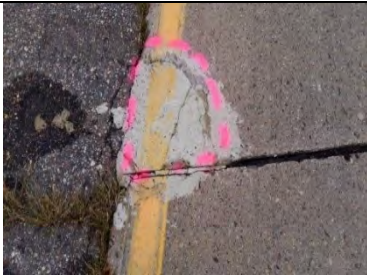
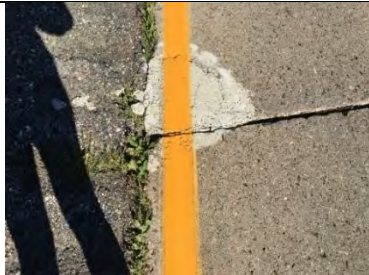
| Cell/Product/Location: 94013(B) – CTS, Rapid Set DOT Repair Mix w/Helix 5-25-SS BA (Stainless Steel) Fibers – CLJ | | |

| 2018 Condition (Rating): Linear cracks (3) | 2019 Condition (Rating): Linear cracks (3) | 2020 Condition (Rating): Linear cracks (3) |

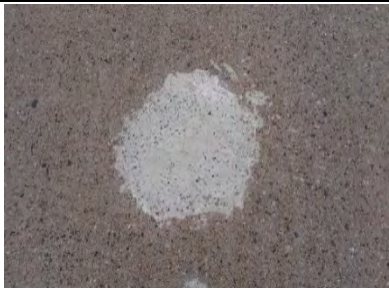
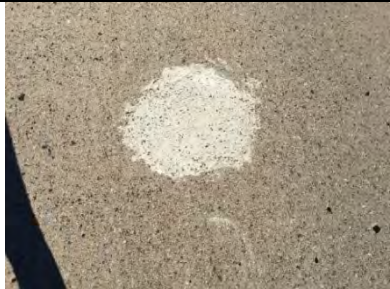
| Cell/Product/Location: 94013(B) – CTS, Rapid Set DOT Repair Mix w/Helix 5-25-SS BA (Stainless Steel) Fibers – Passing CP | | |

| 2018 Condition (Rating): No distress (4) | 2019 Condition (Rating): Linear cracks (3) | 2020 Condition (Rating): Linear cracks (3) |

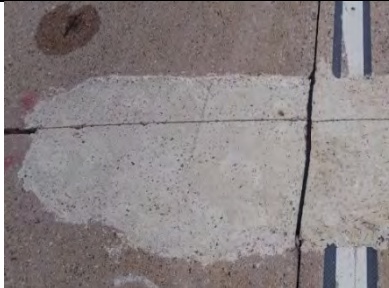
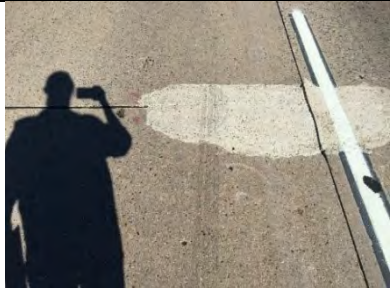
| Cell/Product/Location: 94013(B) – CTS, Rapid Set DOT Repair Mix w/Helix 5-25-SS BA (Stainless Steel) Fibers – Passing ML | | |

| 2018 Condition (Rating): No distress (4) | 2019 Condition (Rating): No distress (4) | 2020 Condition (Rating): No distress (4) |

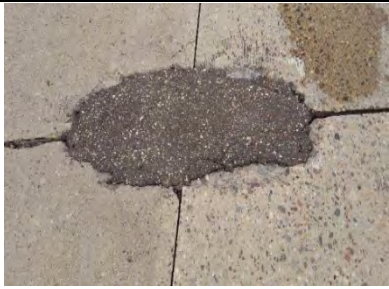
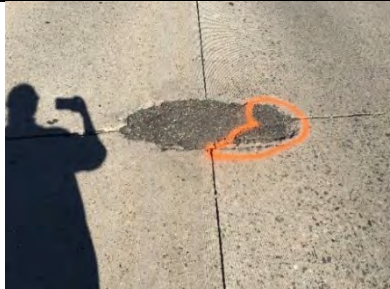
| Cell/Product/Location: 94013(B) – CTS, Rapid Set DOT Repair Mix w/Helix 5-25-SS BA (Stainless Steel) Fibers – Passing WP | | |

| 2018 Condition (Rating): No distress (4) | 2019 Condition (Rating): Shrinkage cracks (4) | 2020 Condition (Rating): Shrinkage cracks (4) |

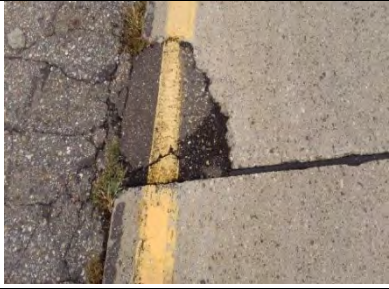
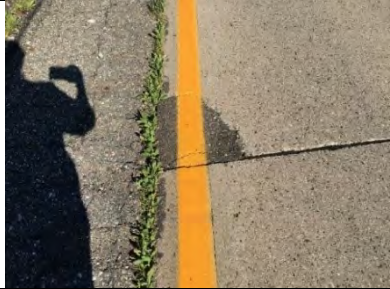
| Cell/Product/Location: 94014 – HMA – CLJ | | |

| 2018 Condition (Rating): N/A | 2019 Condition (Rating): N/A | 2020 Condition (Rating): N/A |

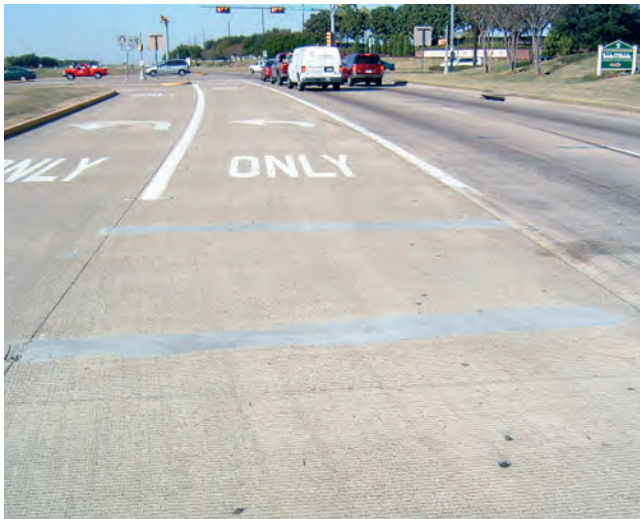
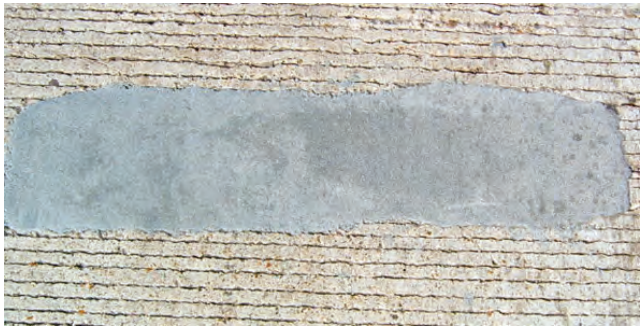
Top and Center images: Highway Spall Repair, Highway 99, Fort Bend County, TX.

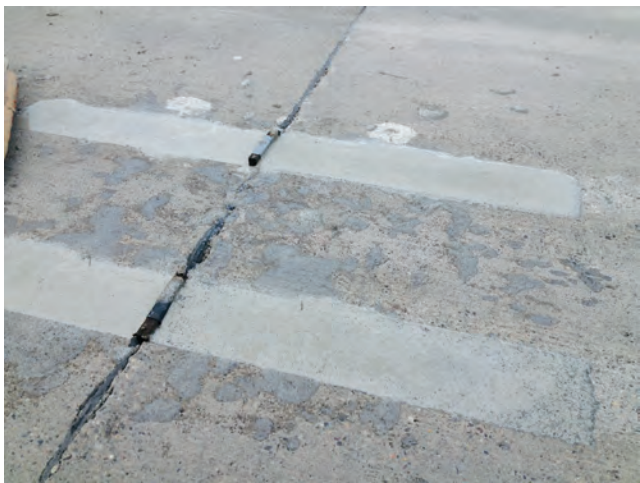
Dowel Bar Retrofit.

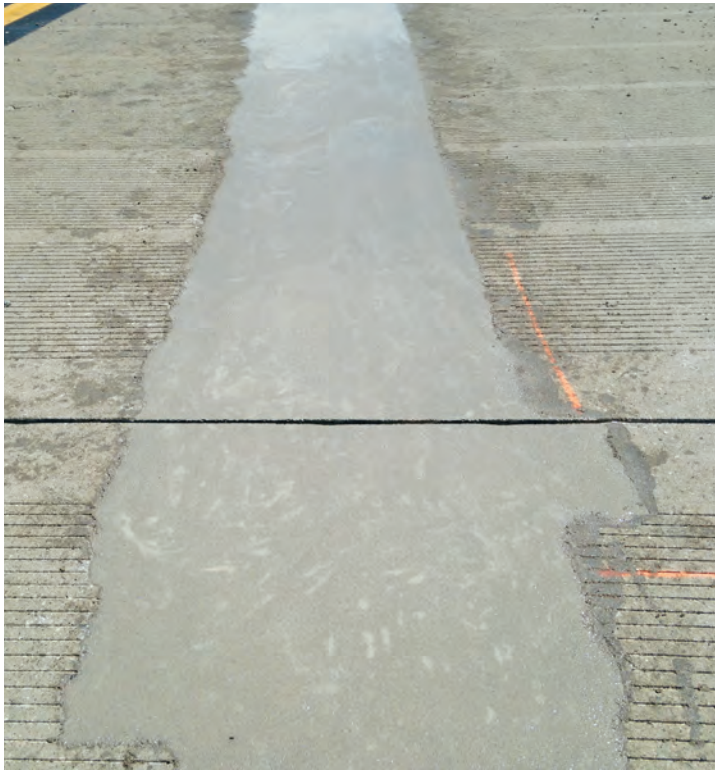
PaveSaver™ Airfield Repair Application

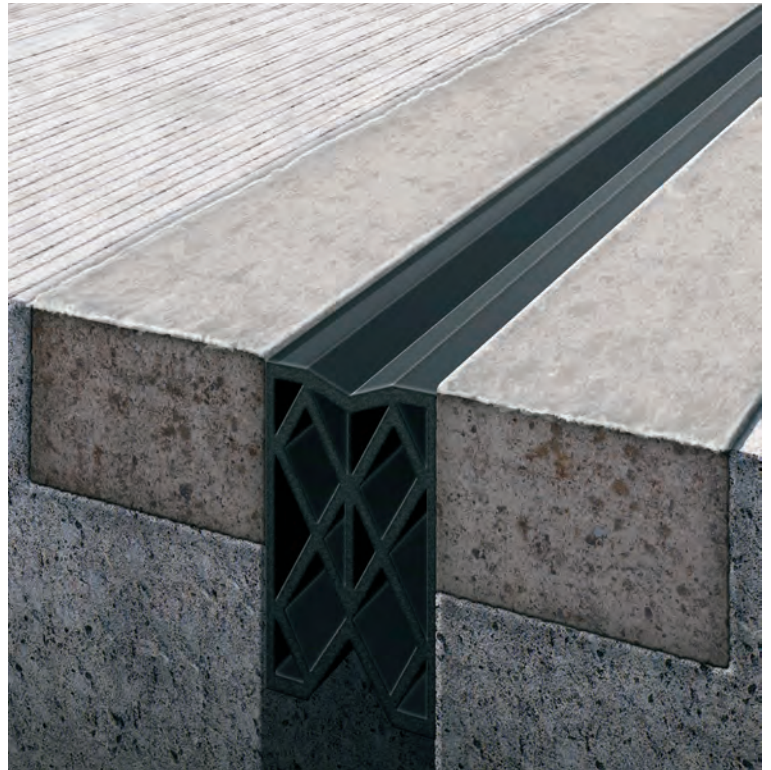
PaveSaver™ Bridge Expansion Joint Header Application
